VE.Bus Error Codes

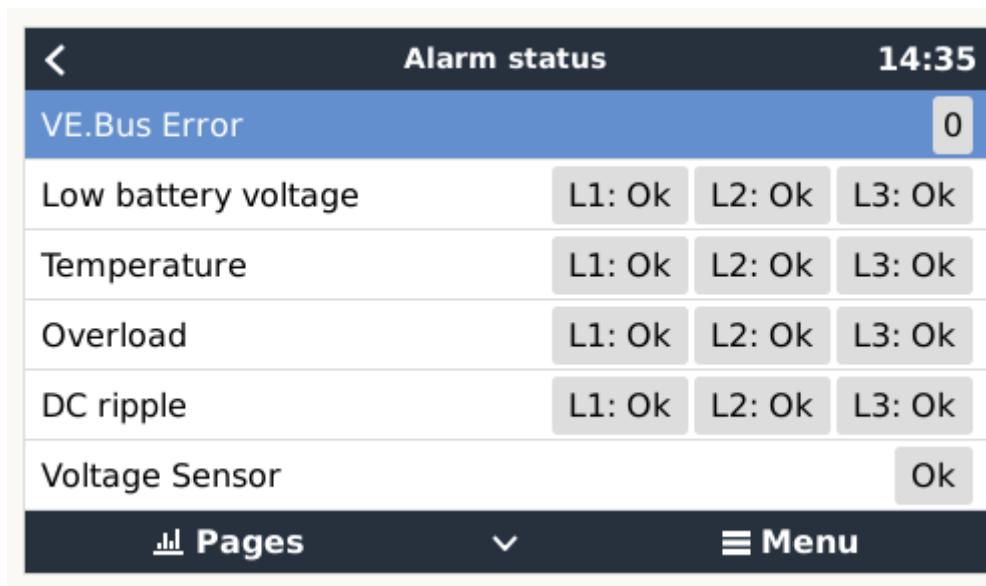
One of the phases in a multi-phase system has failed. Commonly because of a Low battery, Overload or High temperature alarm. When this happens, the other phases will show VE.Bus Error Code 1.

Diagnosing by LEDs Look for the failing phase, which will be the phase that is not showing VE.Bus Error Code 1. And check the LEDs on that phase to find out what the reason was for the shut down; which is typically Overload, Low battery or Temperature. The other units will indicate a VE.Bus error, indicating that they miss one unit.

Diagnosing on a GX Device The GX Device will indicate the VE.Bus Error #1 as well as the alarm status for each of the phases:

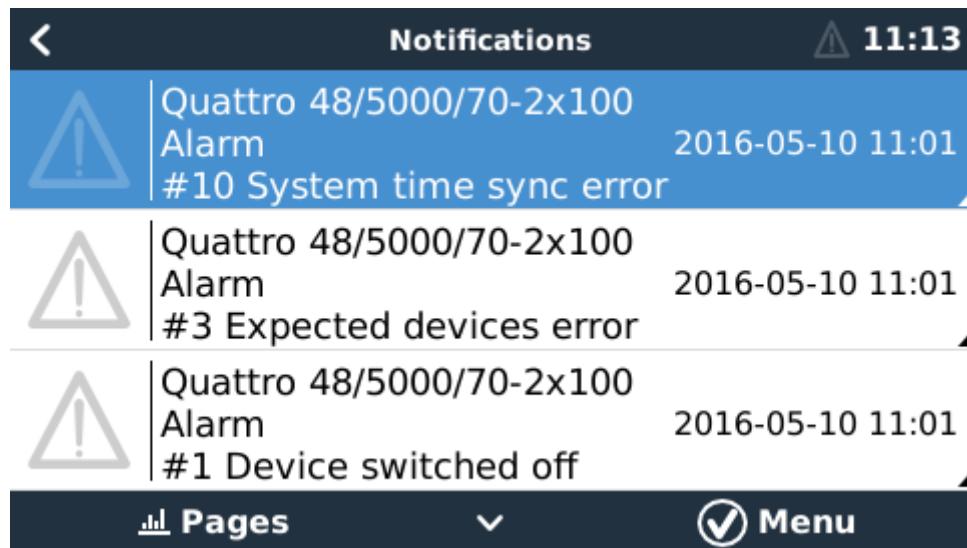
For example this screenshot from the GX device:

The real problem is Error 1. In this example it was caused by switching device L2 off with the front toggle switch. It was then quickly followed by Error 3. And when switching device L2 back on, briefly Error 10 is visible, followed by full recovery.

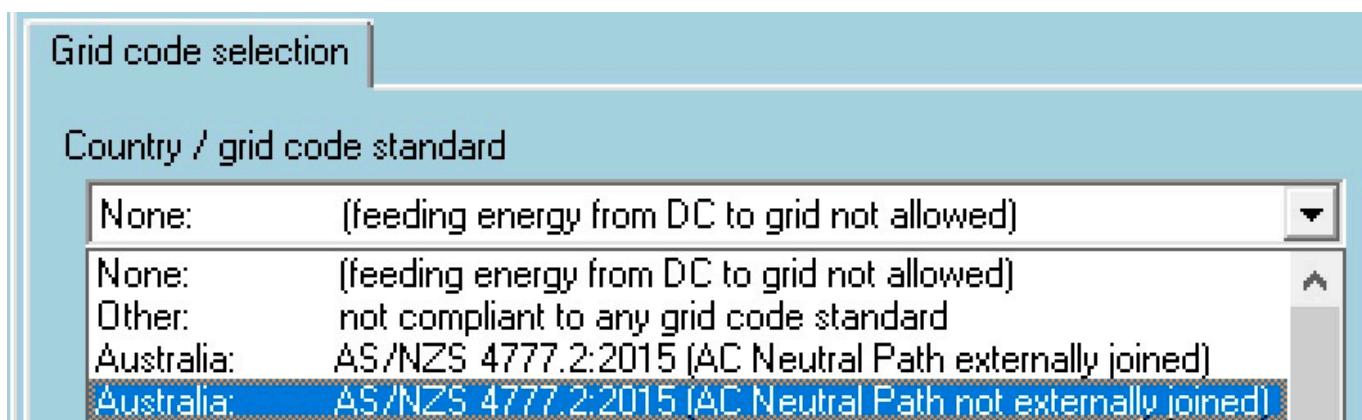
In Australia, using grid code AS4777.2:2015, it may be mandatory to make an external connection between Neutral-in and Neutral-out. Select either design configuration in the grid code section while programming the MultiPlus-II with firmware 466 or above.

After configuration, always confirm that the system is safe with routine electrical safety checks in both modes (eg test RCD operation with AC input connected and disconnected).

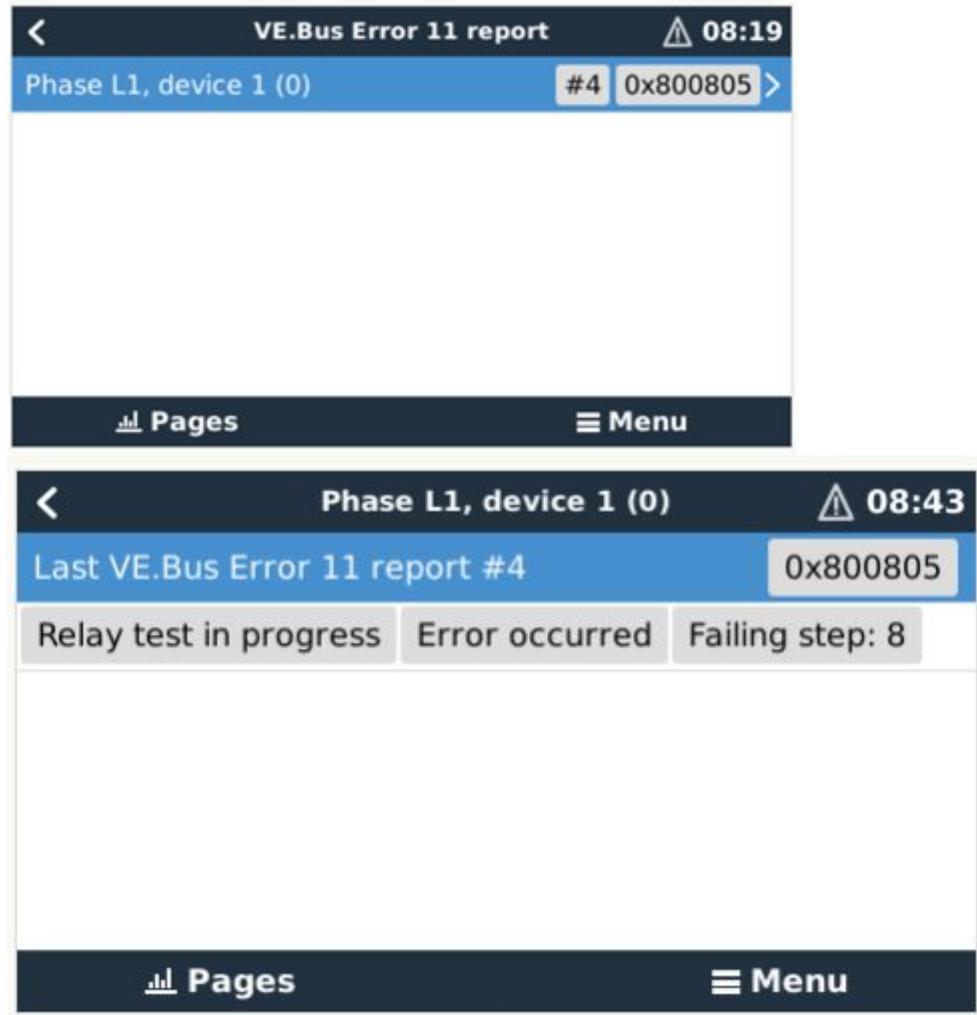
Examples of information in the GX Device menus:

- A six digit number; which contains all the details
- An error ID (#4 in above screenshot). Note that this does not count the number of VE.Bus errors; its just a unique ID that can help recognizing that a new error has occurred.
- Flags
- The failed step; it counts backwards: step 9 → 8 → 7 and so forth.

- Failing step #8: check that line and neutral have not been swapped. Unlike non-grid code installations; line and neutral need to be wired correctly.
- AC0/AC1 mismatch and UMains error: this is fixed in VE.Bus inverter/charger firmware version 455.
