VE.Bus Error Codes

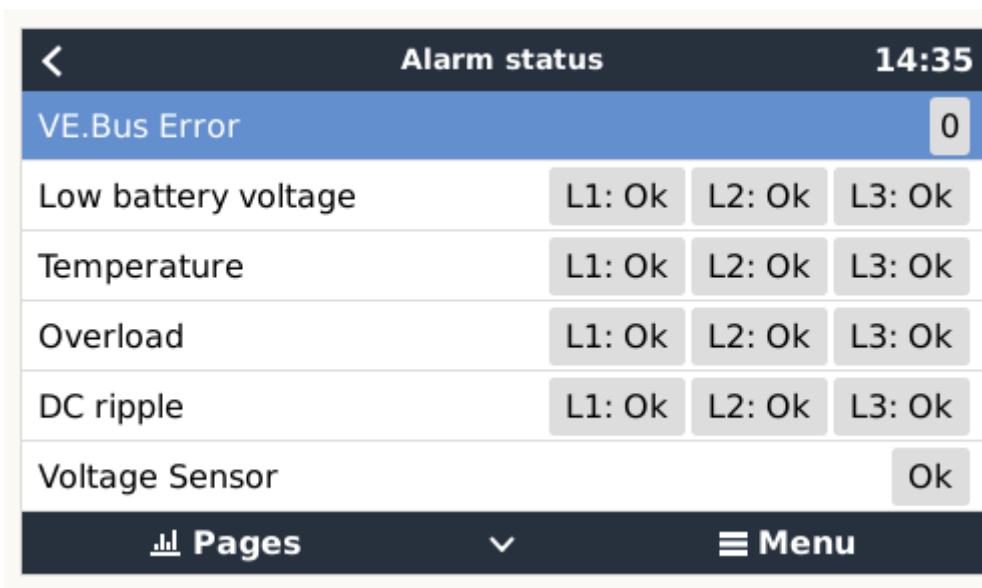
Diagnosing on a GX Device The GX Device will indicate the VE.Bus Error #1 as well as the alarm status for each of the phases:

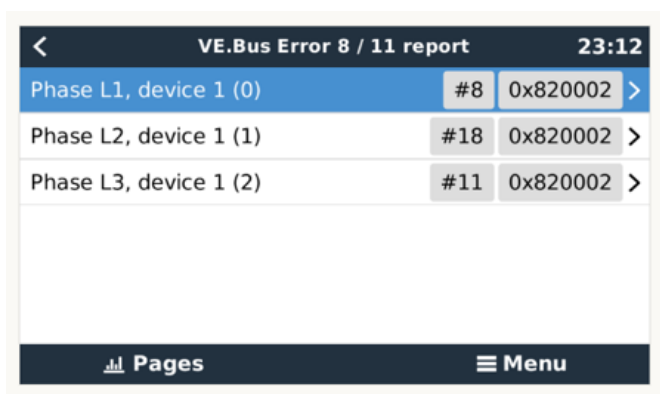
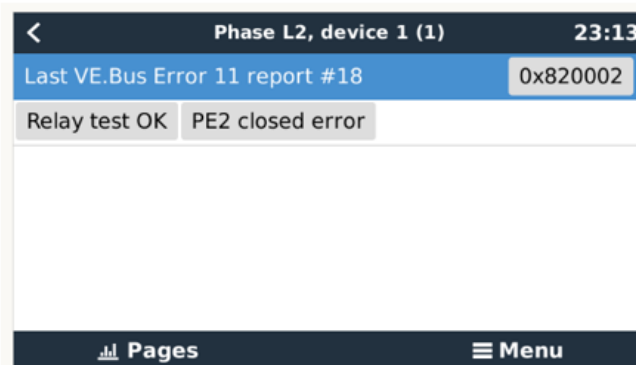
Using a GX device, the underlying detailed error can be seen for each individual inverter/charger in the system:

Note that the pages as shown in above screenshots show the last error that happened in a unit. The errors are stored in non-volatile memory in the inverter/charger, and can therefore be something that was from a long time ago.

Therefore, take care to analyse only the latest error: make a note of the error counter (#8, #18, #11, and so forth in the first screenshot), and then switch the system on again. And after the next shutdown, compare the actual counters with the noted counters. Alternatively, use the Download feature on the Advanced page of the VRM Portal, and analyse the data in Excel.

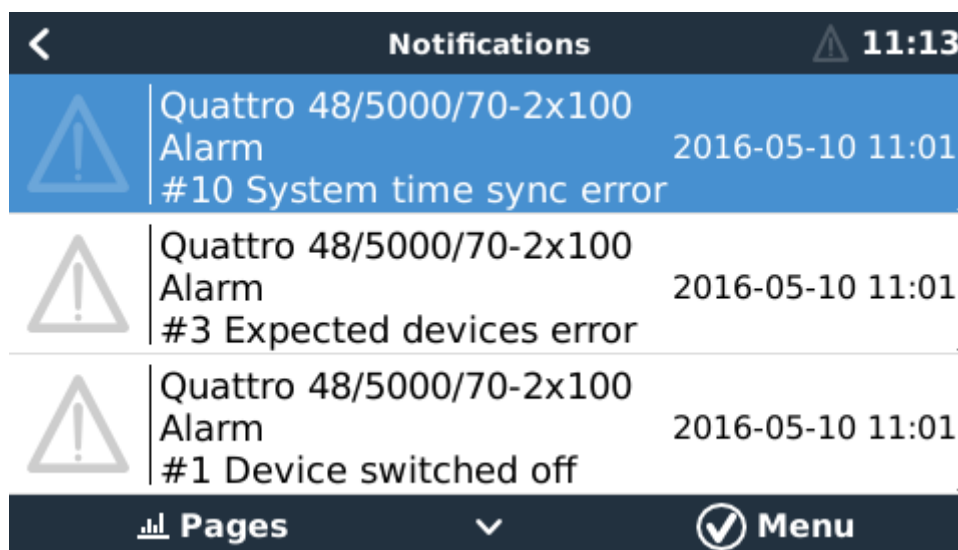
For example this screenshot from the GX device:

The real problem is Error 1. In this example it was caused by switching device L2 off with the front toggle switch. It was then quickly followed by Error 3. And when switching device L2 back on, briefly Error 10 is visible, followed by full recovery.

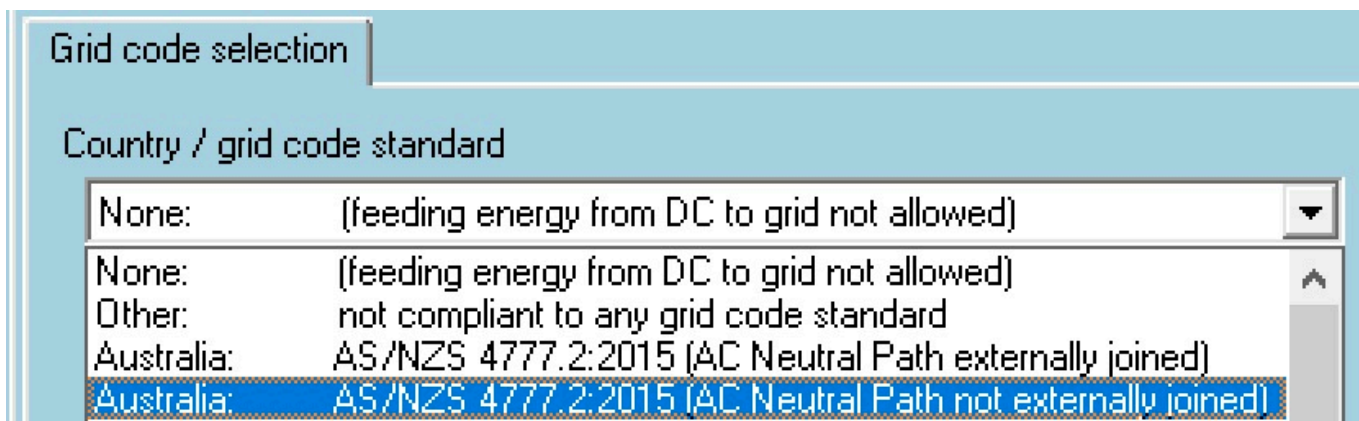
In Australia, using grid code AS4777.2:2015, it may be mandatory to make an external connection between Neutral-in and Neutral-out. Select either design configuration in the grid code section while programming the MultiPlus-II with firmware 466 or above.

After configuration, always confirm that the system is safe with routine electrical safety checks in both modes (eg test RCD operation with AC input connected and disconnected).

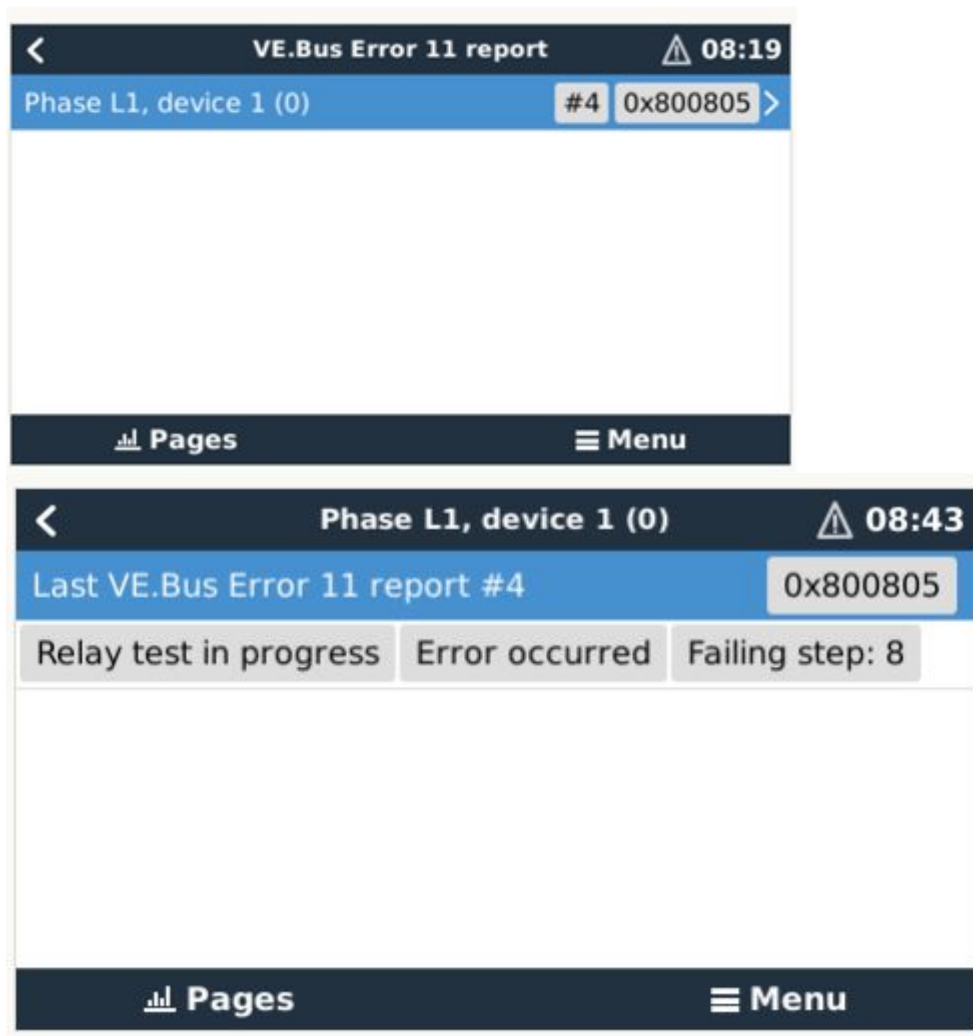
Examples of information in the GX Device menus:

The information shown is:

- A six digit number; which contains all the details
- An error ID (#4 in above screenshot). Note that this does not count the number of VE.Bus errors; its just a unique ID that can help recognizing that a new error has occurred.
- Flags
- The failed step; it counts backwards: step 9 → 8 → 7 and so forth.
