Troubleshooting VE.Bus network interference

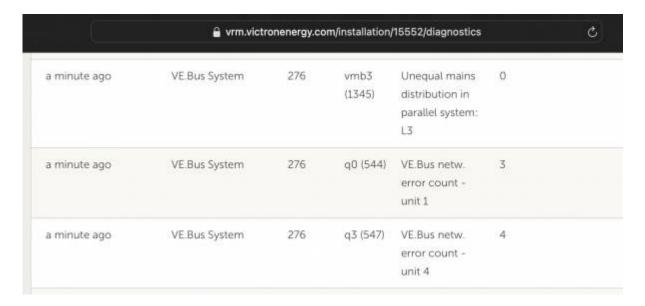
The network quality counters in the VE.Bus system track the number of frame retransmissions required after a VE.Bus device receives an invalid frame. These counters can be accessed via VRM by adding /diagnostics to the VRM URL for a site. They are reset after you 'reset' the VE.Bus system on the GX device in the Multi Advanced menu.

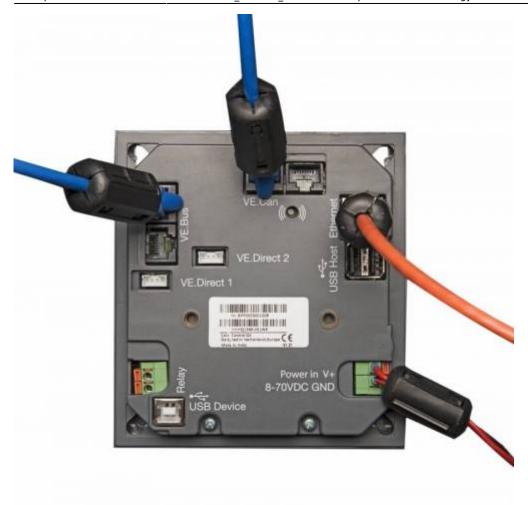
The use of Ferrite core noise suppressing cable clips can also help filter out noise. These are a widely available part and available very cheaply. Some Ferrite core clips are supplied with GX devices and should be attached to the GX cables to reduce in-line noise and interference. The GX power supply ferrite can be installed with a loop to keep it secure.

While not normally necessary, if VE.Bus network errors persist install ferrites on each communications cable in the system at each point of connection. This includes the comms cables between each inverter, between the master inverter and the GX, and the battery comms cables.
