# Troubleshooting VE.Bus network interference

This guide is intended to rule out VE.Bus cables as a cause when troubleshooting spurious VE.Bus error codes. This guide should be considered when the VE.Bus errors appear to be triggered and exacerbated by some load types, load sizes, connection or disconnection of the AC input, temperature, physical disturbance, age, corrosion, and more.

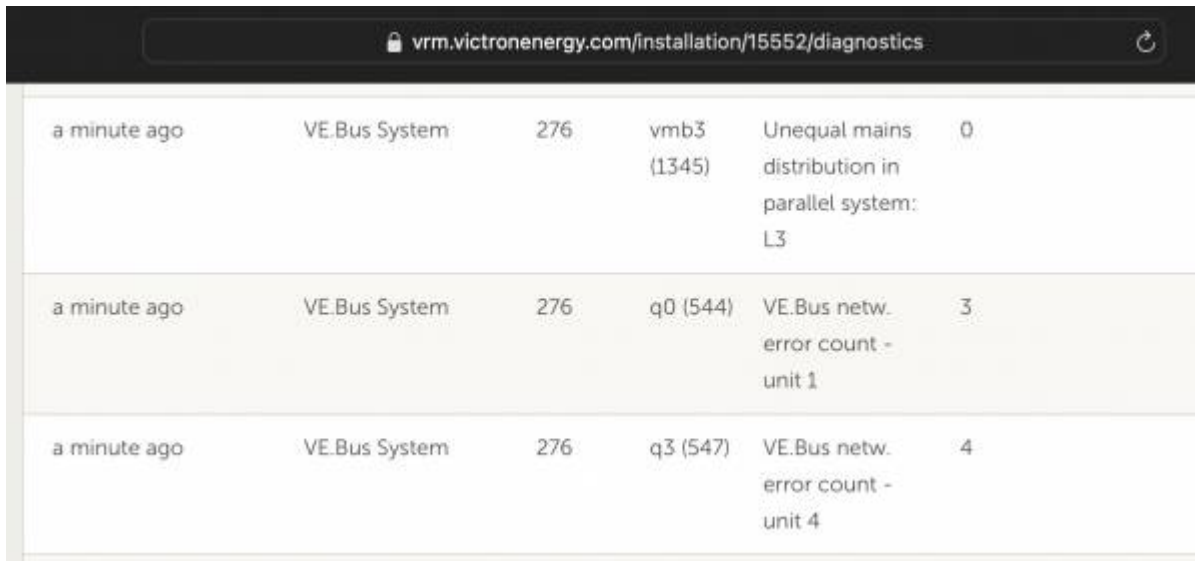
The network quality counters in the VE.Bus system track the number of frame retransmissions required after a VE.Bus device receives an invalid frame. These counters can be accessed via VRM by adding /diagnostics to the VRM URL for a site. They are reset after you 'reset' the VE.Bus system on the GX device in the Multi Advanced menu.

Time	System	Value	Unit	Error Count	
a minute ago	VE.Bus System	276	vmb3 (1345)	Unequal mains distribution in parallel system: L3	0
a minute ago	VE.Bus System	276	q0 (544)	VE.Bus netw. error count - unit 1	3
a minute ago	VE.Bus System	276	q3 (547)	VE.Bus netw. error count - unit 4	4
