### **Color Control GX FAQ**

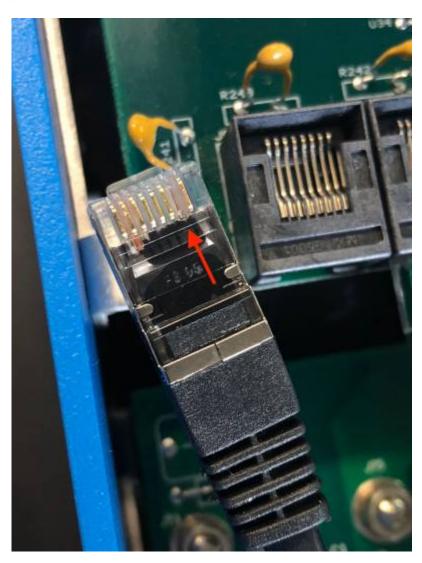
ethernet cable colour coding) allows the VE.Bus products to start up without waiting for the CCGX to boot up first.

Note that when using a Redflow ZBM2/ZCell battery, pin 7 should be cut even if the CCGX is DC powered, to avoid the same deadlock at times when the Redflow battery cluster is at 0% SoC.

The *disadvantage* of cutting pin 7 is that switching the VE.Bus device off will be less effective: although it will stop charging and inverting, it will still be in standby mode and therefore drawing more current from the battery than if pin 7 had been left in place. Typically this is only relevant in Marine or Automotive systems where it's normal to regularly switch the VE.Bus device off. For those types of systems we recommend that you do not cut pin 7, but simply power the CCGX from the battery.
