Color Control GX FAQ

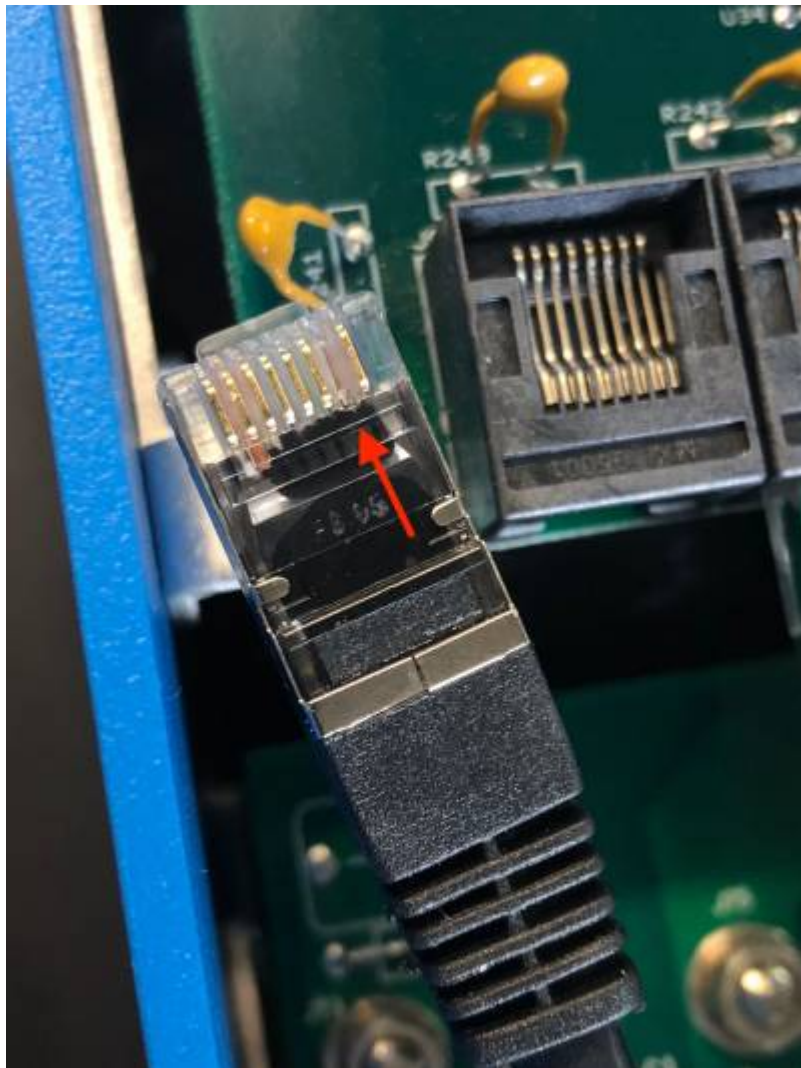
Cutting/Removing pin 7 of the VE.Bus cable to the CCGX (brown/white according to standard RJ45 ethernet cable colour coding) allows the VE.Bus products to start up without waiting for the CCGX to boot up first.

Note that when using a Redflow ZBM2/ZCell battery, pin 7 should be cut even if the CCGX is DC powered, to avoid the same deadlock at times when the Redflow battery cluster is at 0% SoC.

The *disadvantage* of cutting pin 7 is that switching the VE.Bus device off will be less effective: although it will stop charging and inverting, it will still be in standby mode and therefore drawing more current from the battery than if pin 7 had been left in place. Typically this is only relevant in Marine or Automotive systems where it's normal to regularly switch the VE.Bus device off. For those types of systems we recommend that you do not cut pin 7, but simply power the CCGX from the battery.
