# Color Control GX FAQ

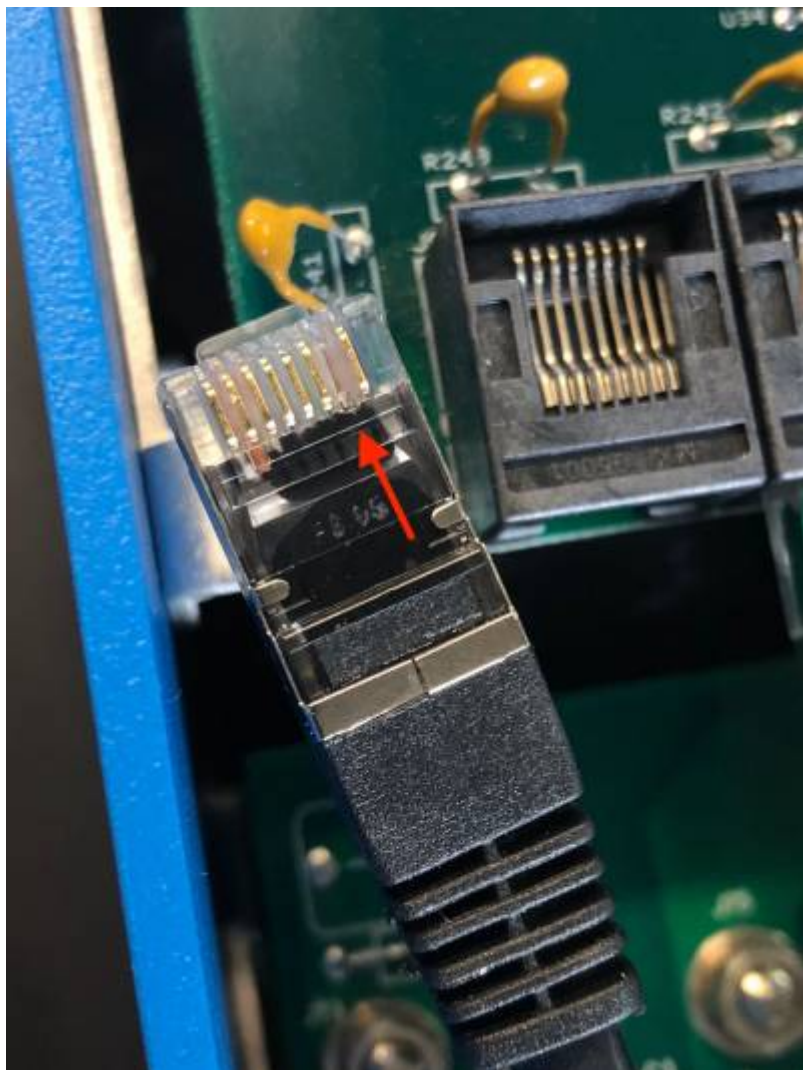
Cutting/Removing pin 7 of the VE.Bus cable to the CCGX (brown/white according to standard RJ45 ethernet cable colour coding) allows the VE.Bus products to start up without waiting for the CCGX to boot up first.

Note that when using a Redflow ZBM2/ZCell battery, pin 7 should be cut even if the CCGX is DC powered, to avoid the same deadlock at times when the Redflow battery cluster is at 0% SoC.

The *disadvantage* of cutting pin 7 is that switching the VE.Bus device off will be less effective: although it will stop charging and inverting, it will still be in standby mode and therefore drawing more current from the battery than if pin 7 had been left in place. Typically this is only relevant in Marine or Automotive systems where it's normal to regularly switch the VE.Bus device off. For those types of systems we recommend that you do not cut pin 7, but simply power the CCGX from the battery.
