CCGX: Updating firmware (pre v2.00)

Intro

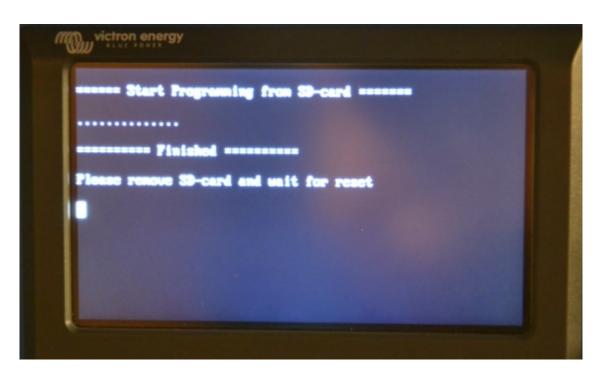
2.7 Wait until the screen is black and you see white text: 'Programming'

2.8 Release button E and follow onscreen instructions
