CCGX: Updating firmware (pre v2.00)

Note that this pages describes an old procedure. See here for the latest information.

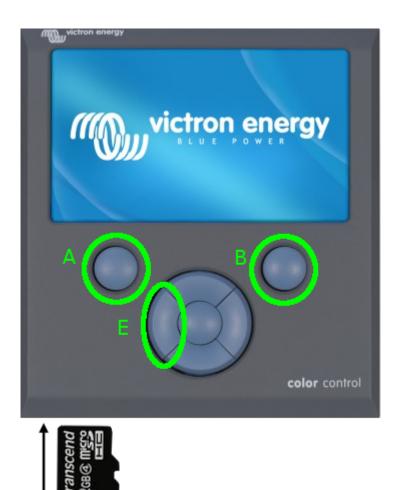
2.4 Place the microSD-card or USB-stick in the Color Control

- Make sure it is formatted with FAT or FAT32. Nothing else, also no exFAT.
- Extract all files from the zip file in to the root-folder of the microSD or USB-stick.
- Use the Windows Safely remove device function before taking the microSD or USB-stick out of the computer. On Linux and Apple this is called Eject.

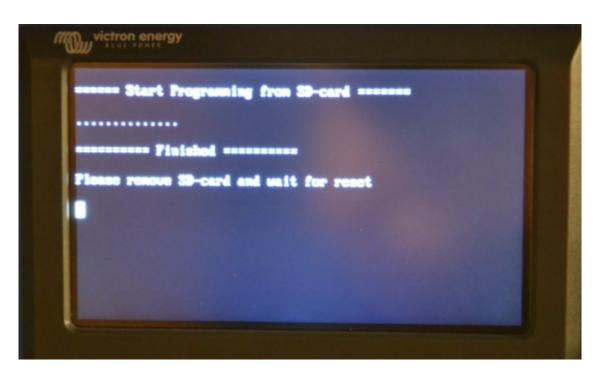
2.7 Wait until the screen is black and you see white text: 'Programming'

- · Press and hold button E
- Then press buttons A and B at the same time and release them again, while holding button E
