# CCGX: Updating firmware (pre v2.00)

## Intro

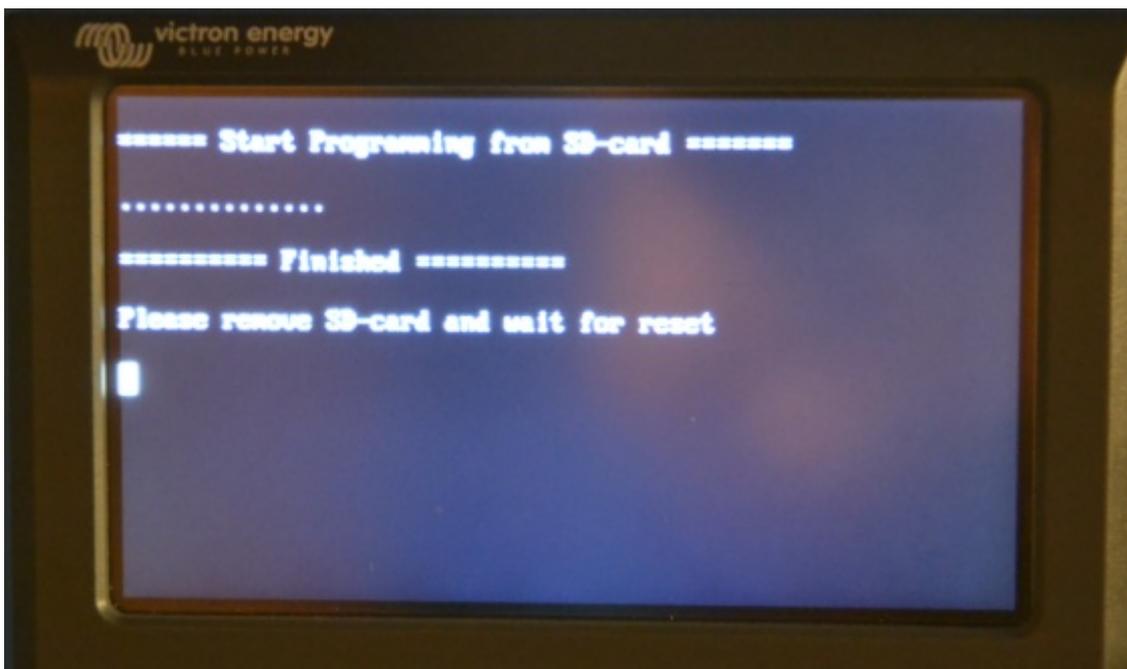
## 2.7 Wait until the screen is black and you see white text: 'Programming'

## 2.8 Release button E and follow onscreen instructions

This is the text shown during programming:
