CCGX: Upgrading to v2.00

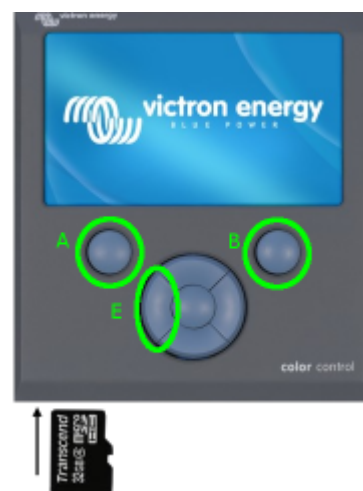
1. Download [venus-upgrade-image.card](#)
2. Unzip it, and put its contents on a microSD card. The card needs to be formatted with either a FAT or FAT32 file system.
3. Click 'Safely remove hardware' or another eject function on your computer.
4. Take the card out
5. Insert the card into the Ccgx
6. Press and hold (!) button E
7. Shortly press A and B at the same time (still hold button E!)
8. The screen will now briefly switch off, then turn solid blue and show 'prepare update'
9. Release button E
10. Next you'll see the update progressing, all kinds of technical details flying by.
11. After approximately 2 minutes, you'll see "Remove SD/USB medium and reset system"
12. So, remove the card, and press buttons A and B again to reboot.
