CCGX: Upgrading to v2.00

Unlike previous updates, v2.00 can not be installed from the internet. Instead it needs a one time manual upgrade. After this, future updates can be installed automatically from the internet again.

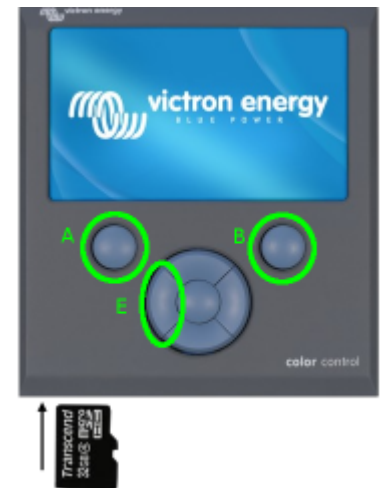
1. Download [venus-upgrade-image.card](#)
2. Unzip it, and put its contents on a microSD card. The card needs to be formatted with either a FAT or FAT32 file system.
3. Click 'Safely remove hardware' or another eject function on your computer.
4. Take the card out
5. Insert the card into the Ccgx
6. Press and hold (!) button E
7. Shortly press A and B at the same time (still hold button E!)
8. The screen will now briefly switch off, then turn solid blue and show 'prepare update'
9. Release button E
10. Next you'll see the update progressing, all kinds of technical details flying by.
11. After approximately 2 minutes, you'll see "Remove SD/USB medium and reset system"
12. So, remove the card, and press buttons A and B again to reboot.
