CCGX: Upgrading to v2.00

Unlike previous updates, v2.00 can not be installed from the internet. Instead it needs a one time manual upgrade. After this, future updates can be installed automatically from the internet again.

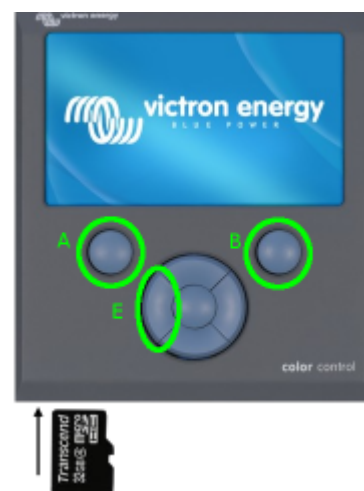
1. Download [venus-upgrade-image-ccgx.zip](#)
2. Unzip it, and put its contents on a microSD card. The card needs to be formatted with either a FAT or FAT32 file system.
3. Click 'Safely remove hardware' or another eject function on your computer.
4. Take the card out
5. Insert the card into the Ccgx
6. Press and hold (!) button E
7. Shortly press A and B at the same time (still hold button E!)
8. The screen will now briefly switch off, then turn solid blue and show 'prepare update'
9. Release button E
10. Next you'll see the update progressing, all kinds of technical details flying by.
11. After approximately 2 minutes, you'll see "Remove SD/USB medium and reset system"
12. So, remove the card, and press buttons A and B again to reboot.
