CCGX: Upgrading to v2.00

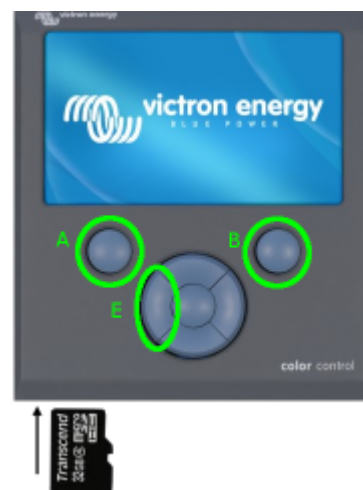
The upgrade procedure:

1. Download [venus-upgrade-image-ccgx.zip](#)
2. Unzip it, and put its contents on a microSD card. The card needs to be formatted with either a FAT or FAT32 file system.
3. Click 'Safely remove hardware' or another eject function on your computer.
4. Take the card out
5. Insert the card into the Ccgx
6. Press and hold (!) button E
7. Shortly press A and B at the same time (still hold button E!)
8. The screen will now briefly switch off, then turn solid blue and show 'prepare update'
9. Release button E
10. Next you'll see the update progressing, all kinds of technical details flying by.
11. After approximately 2 minutes, you'll see "Remove SD/USB medium and reset system"
12. So, remove the card, and press buttons A and B again to reboot.
