CCGX: Upgrading to v2.00

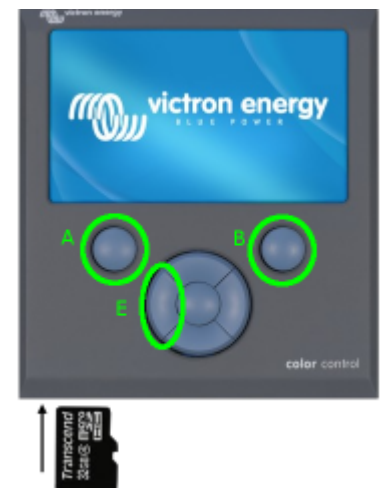
1. Download [venus-upgrade-image-ccgx.zip](#)
2. Unzip it, and put its contents on a microSD card. The card needs to be formatted with either a FAT or FAT32 file system.
3. Click 'Safely remove hardware' or another eject function on your computer.
4. Take the card out
5. Insert the card into the Ccgx
6. Press and hold (!) button E
7. Shortly press A and B at the same time (still hold button E!)
8. The screen will now briefly switch off, then turn solid blue and show 'prepare update'
9. Release button E
10. Next you'll see the update progressing, all kinds of technical details flying by.
11. After approximately 2 minutes, you'll see "Remove SD/USB medium and reset system"
12. So, remove the card, and press buttons A and B again to reboot.
