CCGX: Upgrading to v2

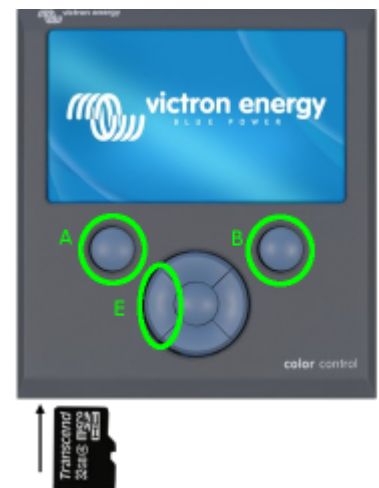
The upgrade procedure:

1. Download [venus-upgrade-image-ccgx.zip](#)
2. Unzip it, and put its contents on a microSD card. The card needs to be formatted with either a FAT or FAT32 file system.
3. Click 'Safely remove hardware' or another eject function on your computer.
4. Take the card out
5. Insert the card into the Ccgx
6. Press and hold (!) button E
7. Shortly press A and B at the same time (still hold button E!)
8. The screen will now briefly switch off, then turn solid blue and show 'prepare update'
9. Release button E
10. Next you'll see the update progressing, all kinds of technical details flying by.
11. After approximately 2 minutes, you'll see "Remove SD/USB medium and reset system"
12. So, remove the card, and press buttons A and B again to reboot.
