# CCGX: Upgrading to v2

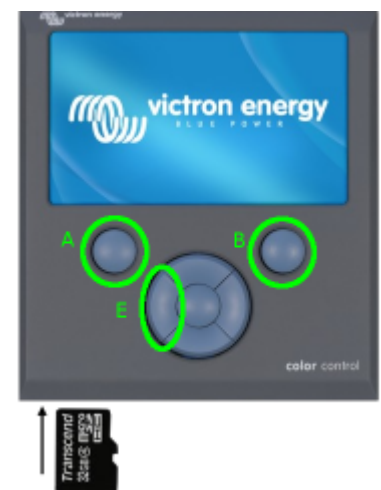
1. Download [venus-upgrade-image-ccgx.zip](#)
2. Unzip it, and put its contents on a microSD card. The card needs to be formatted with either a FAT or FAT32 file system.
3. Click 'Safely remove hardware' or another eject function on your computer.
4. Take the card out
5. Insert the card into the Ccgx
6. Press and hold (!) button E
7. Shortly press A and B at the same time (still hold button E!)
8. The screen will now briefly switch off, then turn solid blue and show 'prepare update'
9. Release button E
10. Next you'll see the update progressing, all kinds of technical details flying by.
11. After approximately 2 minutes, you'll see "Remove SD/USB medium and reset system"
12. So, remove the card, and press buttons A and B again to reboot.
