CCGX: Upgrading to v2

Unlike previous updates, v2.00 can not be installed from the internet. Instead it needs a one time manual upgrade. After this, future updates can be installed automatically from the internet again.

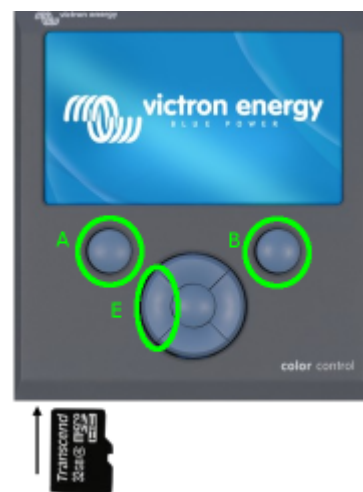
The upgrade procedure:

1. Download [venus-upgrade-image-ccgx.zip](#)
2. Unzip it, and put its contents on a microSD card. The card needs to be formatted with either a FAT or FAT32 file system.
3. Click 'Safely remove hardware' or another eject function on your computer.
4. Take the card out
5. Insert the card into the Ccgx
6. Press and hold (!) button E
7. Shortly press A and B at the same time (still hold button E!)
8. The screen will now briefly switch off, then turn solid blue and show 'prepare update'
9. Release button E
10. Next you'll see the update progressing, all kinds of technical details flying by.
11. After approximately 2 minutes, you'll see "Remove SD/USB medium and reset system"
12. So, remove the card, and press buttons A and B again to reboot.
