# CCGX: Upgrading to v2

Unlike previous updates, v2.00 can not be installed from the internet. The latest available version before v2.00 is v1.74.

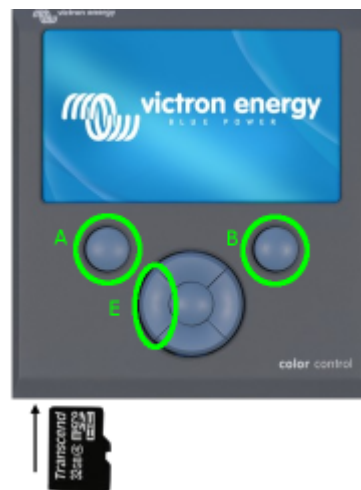
The upgrade procedure:

1. Download [venus-upgrade-image-ccgx.zip](#)
2. Unzip it, and put its contents on a microSD card. The card needs to be formatted with either a FAT or FAT32 file system.
3. Click 'Safely remove hardware' or another eject function on your computer.
4. Take the card out
5. Insert the card into the Ccgx
6. Press and hold (!) button E
7. Shortly press A and B at the same time (still hold button E!)
8. The screen will now briefly switch off, then turn solid blue and show 'prepare update'

9. Release button E
10. Next you'll see the update progressing, all kinds of technical details flying by.
11. After approximately 2 minutes, you'll see "Remove SD/USB medium and reset system"
12. So, remove the card, and press buttons A and B again to reboot.
