# CCGX: Upgrading to v2

Unlike previous updates, v2.00 can not be installed from the internet. The latest available version before v2.00 is v1.74.

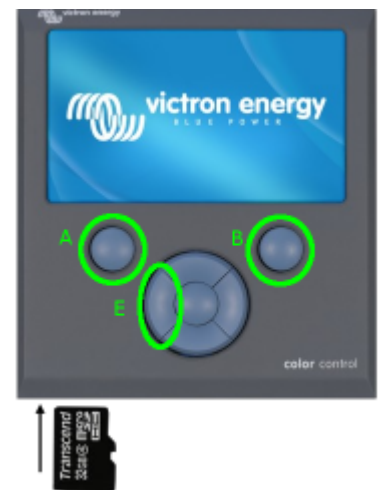
The upgrade procedure:

1. Download [venus-upgrade-image-ccgx.zip](#)
2. Unzip it, and put its contents on a microSD card. The card needs to be formatted with either a FAT or FAT32 file system.
3. Click 'Safely remove hardware' or another eject function on your computer.
4. Take the card out
5. Insert the card into the Ccgx
6. Press and hold (!) button E
7. Shortly press A and B at the same time (still hold button E!)
8. The screen will now briefly switch off, then turn solid blue and show 'prepare update'

9. Release button E
10. Next you'll see the update progressing, all kinds of technical details flying by.
11. After approximately 2 minutes, you'll see "Remove SD/USB medium and reset system"
12. So, remove the card, and press buttons A and B again to reboot.

Make sure to hold (!) button E till the upgrade starts
