CCGX: Upgrading to v2

After v1.74, the next version is v2.00. Installing v2.00 (or later) on a CCGX with version v1.74 (or earlier) requires a one time manual upgrade.

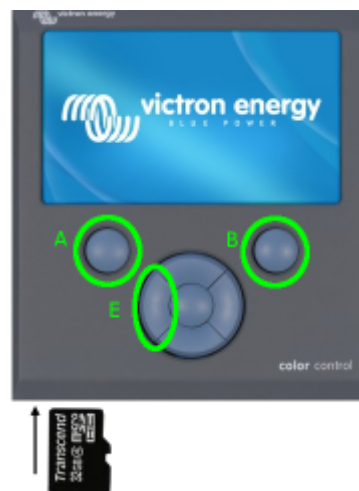
1. Download [venus-upgrade-image-ccgx.zip](#)
2. Unzip it, and put its contents on a microSD card. The card needs to be formatted with either a FAT or FAT32 file system.
3. Click 'Safely remove hardware' or another eject function on your computer.
4. Take the card out
5. Insert the card into the Ccgx
6. Press and hold (!) button E
7. Shortly press A and B at the same time (still hold button E!)

8. The screen will now briefly switch off, then turn solid blue and show 'prepare update'
9. Release button E
10. Next you'll see the update progressing, all kinds of technical details flying by.
11. After approximately 2 minutes, you'll see "Remove SD/USB medium and reset system"
12. So, remove the card, and press buttons A and B again to reboot.

Make sure to hold (!) button E till the upgrade starts
