CCGX: Upgrading to v2

Updating a CCGX from v1.74 to a newer version requires a one time manual upgrade.

This document explains the one time manual upgrade procedure.

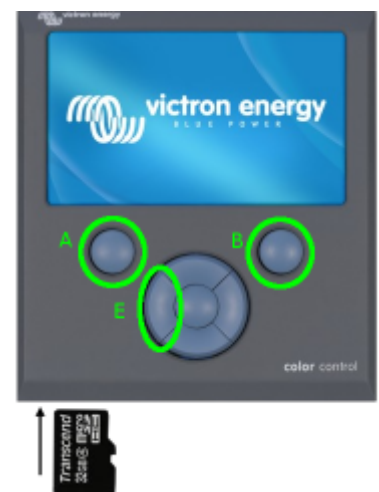
1. Download [venus-upgrade-image-ccgx.zip](#)
2. Above link always points to the latest available version.
3. Unzip it, and put its contents on a microSD card. The card needs to be formatted with either a FAT or FAT32 file system.
4. Click 'Safely remove hardware' or another eject function on your computer.
5. Take the card out
6. Insert the card into the Ccgx

7. Press and hold (!) button E
8. Shortly press A and B at the same time (still hold button E!)
9. The screen will now briefly switch off, then turn solid blue and show 'prepare update'
10. Release button E
11. Next you'll see the update progressing, all kinds of technical details flying by.
12. After approximately 2 minutes, you'll see "Remove SD/USB medium and reset system"
13. So, remove the card, and press buttons A and B again to reboot.

Make sure to hold (!) button E till the upgrade starts

Make sure button A is released after resetting. Pressing both A and E after a reset will interrupt the boot. Try again, and release A before B.
