# CCGX: Upgrading to v2

Updating a CCGX from v1.74 to a newer version requires a one time manual upgrade. This document explains how thats done.

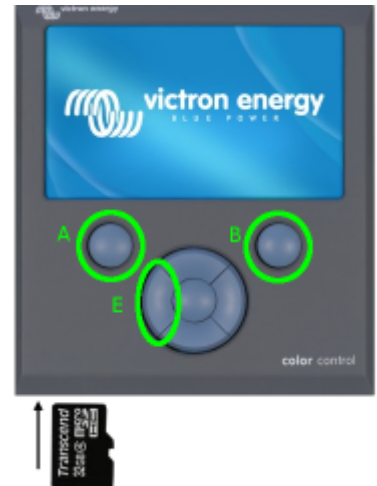
7. Insert the card into the Ccgx
8. Press and hold (!) button E
9. Shortly press A and B at the same time (still hold button E!)
10. The screen will now briefly switch off, then turn solid blue and show 'prepare update'
11. Release button E
12. Next you'll see the update progressing, all kinds of technical details flying by.
13. After approximately 2 minutes, you'll see "Remove SD/USB medium and reset system"
14. So, remove the card, and press buttons A and B again to reboot.
