VE.Bus Error Codes

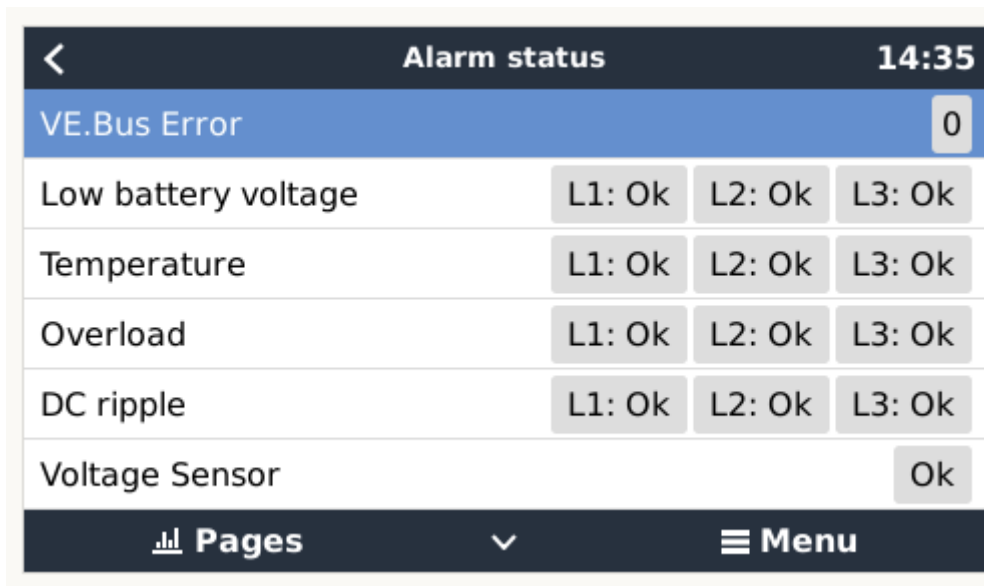
Diagnosing on a GX Device The GX Device will indicate the VE.Bus Error #1 as well as the alarm status for each of the phases:

Note that, due to the automatic restart, it is required to look at the LEDs while the issue is still present and the system is switched off. Uploading the data to VRM will show a log; see GX manual, section VRM for details; both for systems with internet connection and systems without.

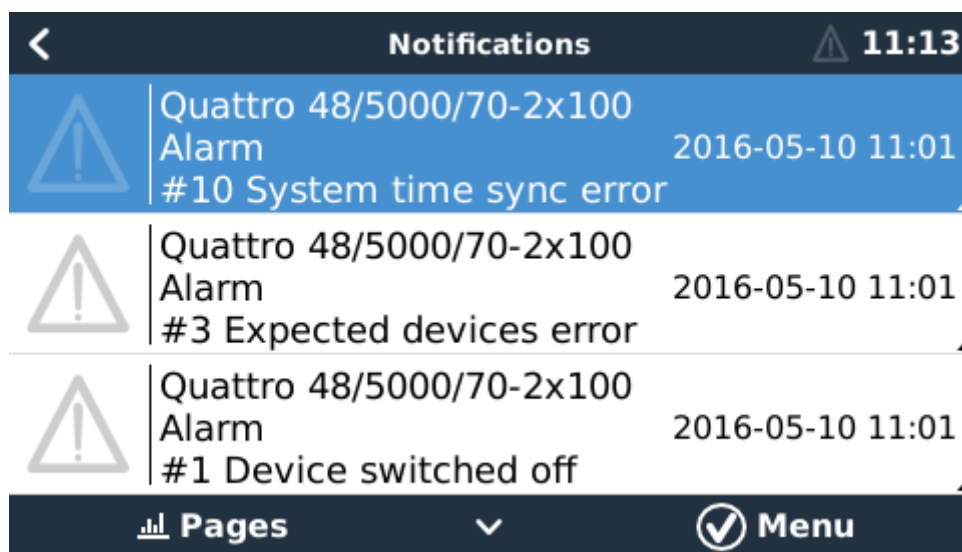
For example this screenshot from the GX device:

The real problem is Error 1. In this example it was caused by switching device L2 off with the front toggle switch. It was then quickly followed by Error 3. And when switching device L2 back on, briefly Error 10 is visible, followed by full recovery.

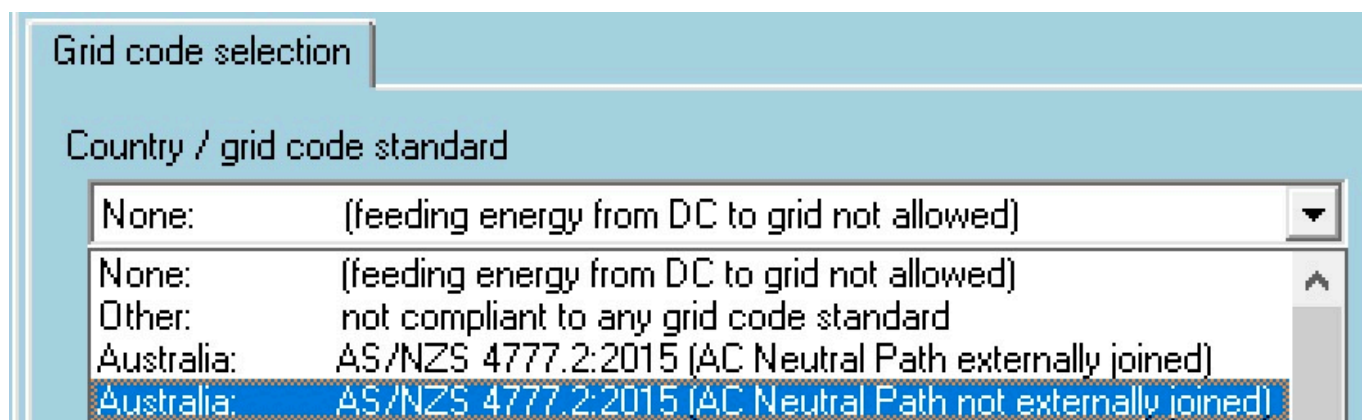
In Australia, using grid code AS4777.2:2015, it may be mandatory to make an external connection between Neutral-in and Neutral-out. Select either design configuration in the grid code section while programming the MultiPlus-II with firmware 466 or above.

After configuration, always confirm that the system is safe with routine electrical safety checks in both modes (eg test RCD operation with AC input connected and disconnected).

Step 4: Check your Neutral-out connection. In most cases there should be no external connection between ACin-Neutral to ACout-Neutral, or to Earth.
