VE.Bus Error Codes

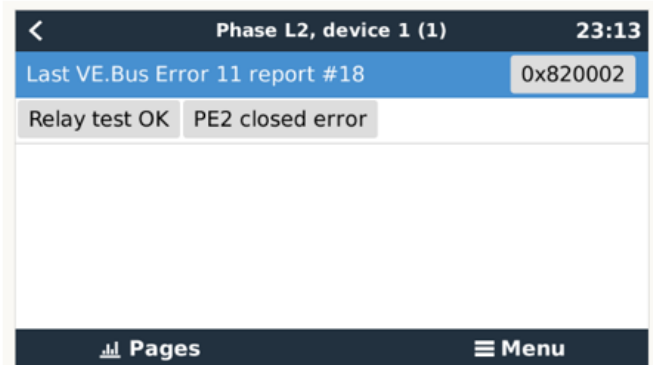
Using a GX device, the underlying detailed error can be seen for each individual inverter/charger in the system:

Definition of ground-relay related error types:

- **GND Relay Error:** Comes from the secondary controller; and can both mean that the relay is measured as being open, while it is expected to be closed, and the other way around.
- **Error: PE2 Open:** Comes from the main controller, means that the relay is measured as being open while expected to be closed.
- **Error: PE2 Closed:** Also comes from the main controller, and means that its measured as

Therefore, take care to analyse only the latest error: make a note of the error counter (#8, #18, #11, and so forth in the first screenshot), and then switch the system on again. And after the next shutdown, compare the actual counters with the noted counters. Alternatively, use the Download feature on the Advanced page of the VRM Portal, and analyse the data in Excel.

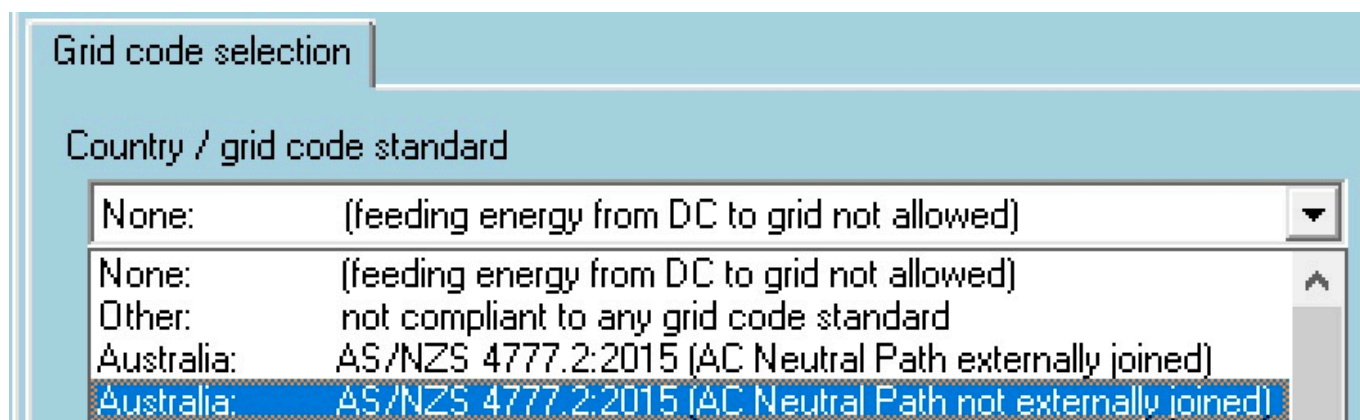
In Australia, using grid code AS4777.2:2015, it may be mandatory to make an external connection between Neutral-in and Neutral-out. Select either design configuration in the grid code section while programming the MultiPlus-II with firmware 466 or above.

Step 4: Check your Neutral-out connection. In most cases there should be no external connection between ACin-Neutral to ACout-Neutral, or to Earth.
