# Troubleshooting VE.Bus network interference

This guide is intended to rule out VE.Bus cables as a cause when troubleshooting spurious VE.Bus error codes. This guide should be considered when the VE.Bus errors appear to be triggered and exacerbated by some load types, load sizes, connection or disconnection of the AC input, temperature, physical disturbance, age, corrosion, and more.

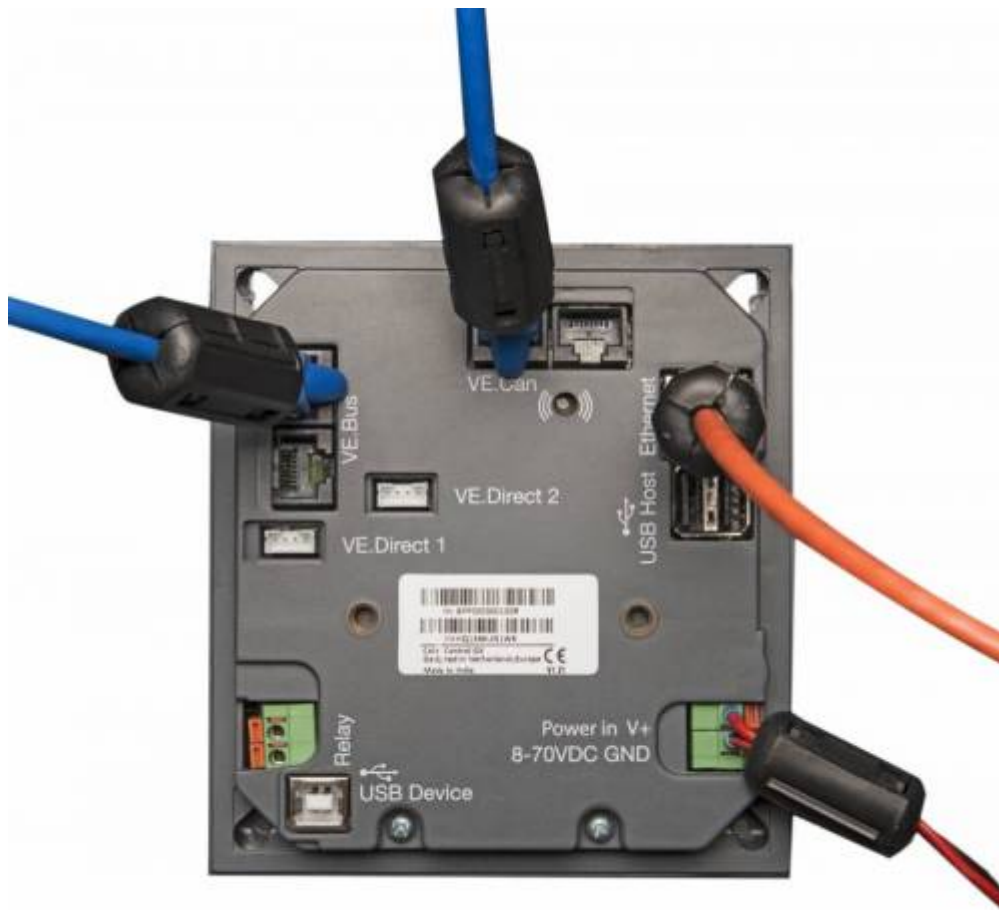
The use of Ferrite core noise suppressing cable clips can also help filter out noise. These are a widely available part and available very cheaply. Some Ferrite core clips are supplied with GX devices and should be attached to the GX cables to reduce in-line noise and interference. The GX power supply ferrite can be installed with a loop to keep it secure.

While not normally necessary, if VE.Bus network errors persist install ferrites on each communications cable in the system at each point of connection. This includes the comms cables between each inverter, between the master inverter and the GX, and the battery comms cables.
