Troubleshooting VE.Bus network interference

This guide is intended to rule out VE.Bus cables as a cause when troubleshooting spurious VE.Bus error codes. This guide should be considered when the VE.Bus errors appear to be triggered and exacerbated by some load types, load sizes, connection or disconnection of the AC input, temperature, physical disturbance, age, corrosion, and more.

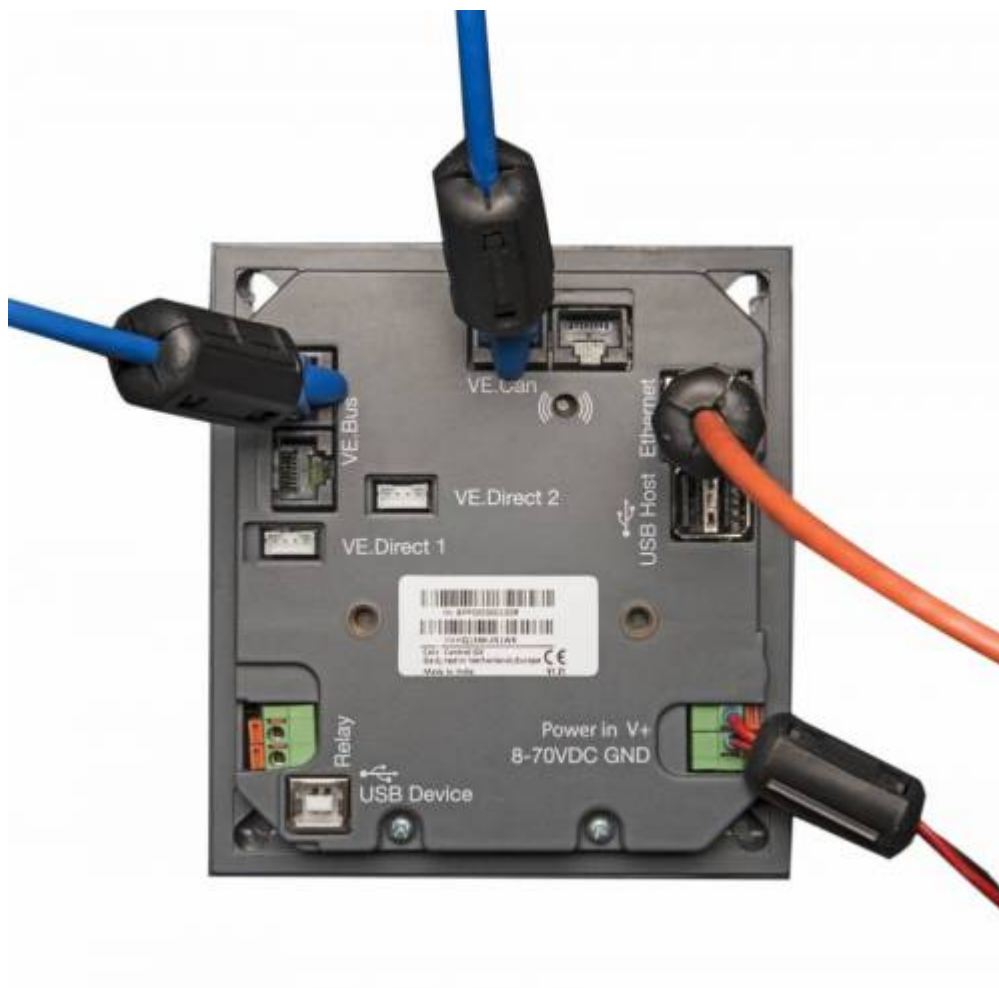
The use of Ferrite core noise suppressing cable clips can also help filter out noise. These are a widely available part and available very cheaply. Some Ferrite core clips are supplied with GX devices and should be attached to the GX cables to reduce in-line noise and interference. The GX power supply ferrite can be installed with a loop to keep it secure.

While not normally necessary, if VE.Bus network errors persist install ferrites on each communications cable in the system at each point of connection. This includes the comms cables between each inverter, between the master inverter and the GX, and the battery comms cables.
