Remote VE.Bus firmware updates

1. Introduction and limitations

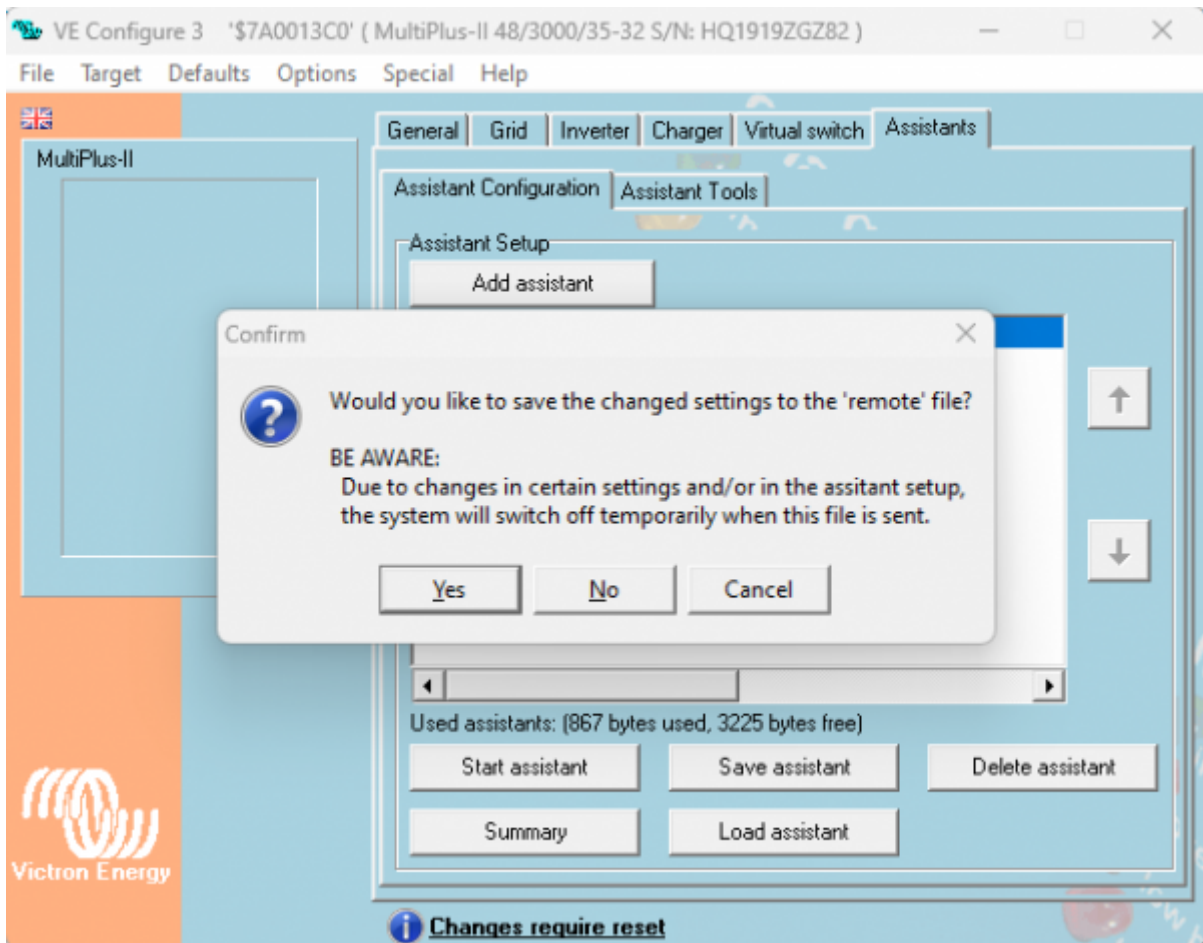
The settings template will need to be converted. It should be a .RVMS file in your download folder (it is saved during the update procedure). Open it by double clicking. If the VE.Bus tools are correctly installed, it will then open in VE.Bus System Configurator, and prompt you about the conversion.

Close VEConfigure (X on upper right of the window), which will automatically prompt saving that converted file:

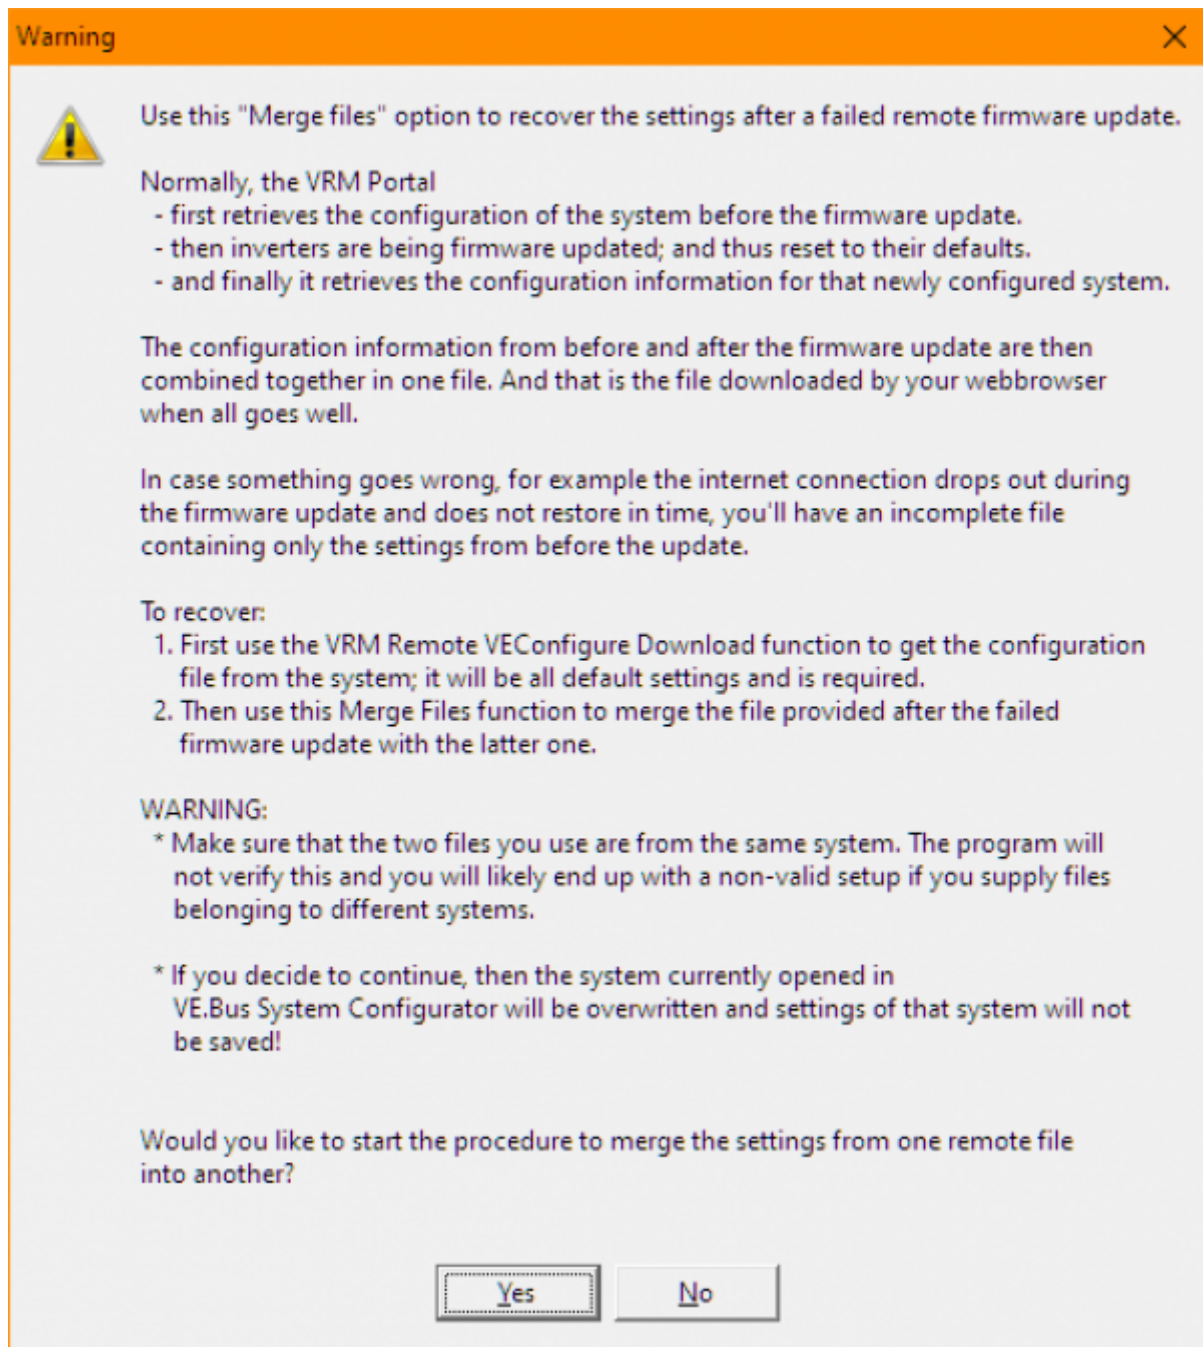
Q3: Merging files: how to recover the old settings when something went wrong

1. In VRM → Device List → Remote VEConfigure, and there click download.
2. Use the merge function in VE.Bus System Configurator:
