# Remote VE.Bus firmware updates

## 1. Introduction and limitations

### 1.1 Introduction

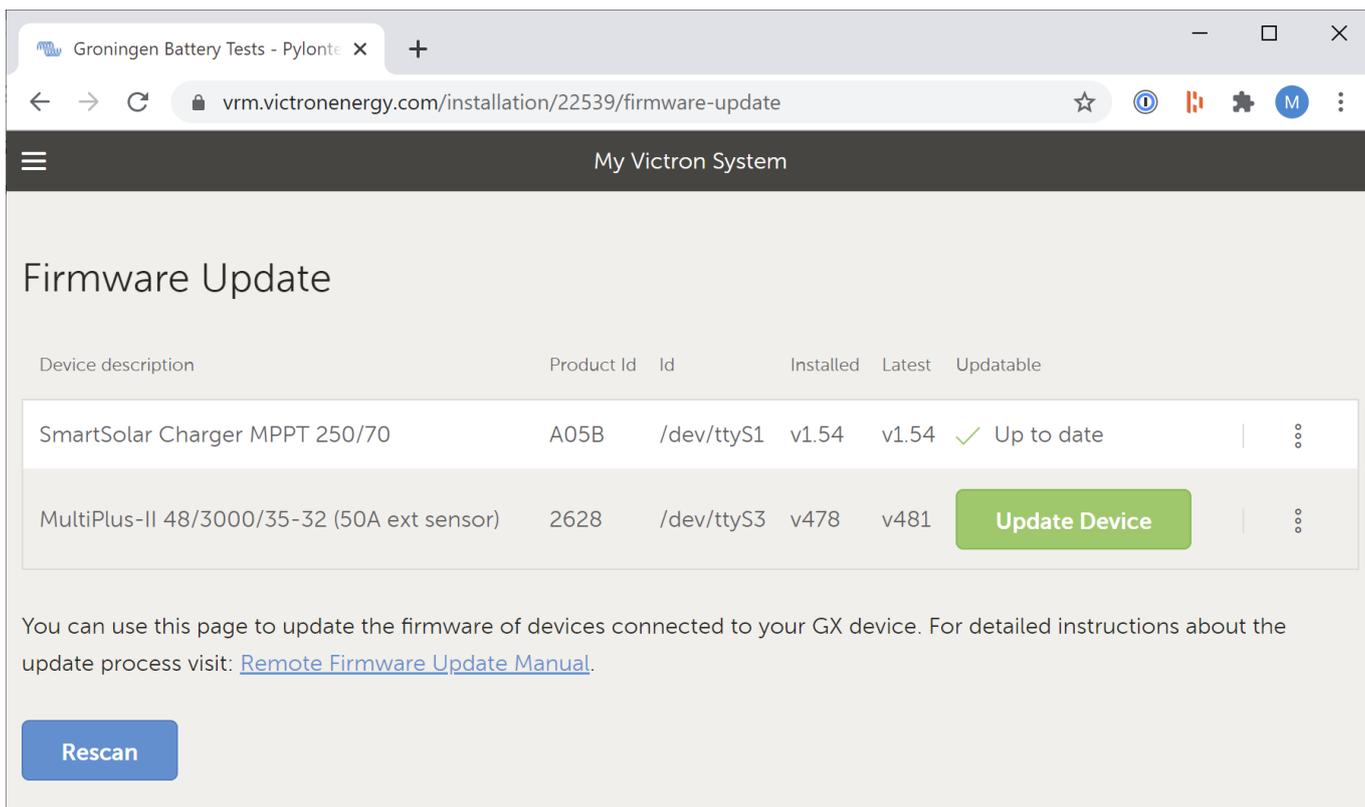
In the VRM Portal, go to the Device List page, and click the Firmware update button at the bottom of the page. The system will now search for connected devices and once completed show the result:

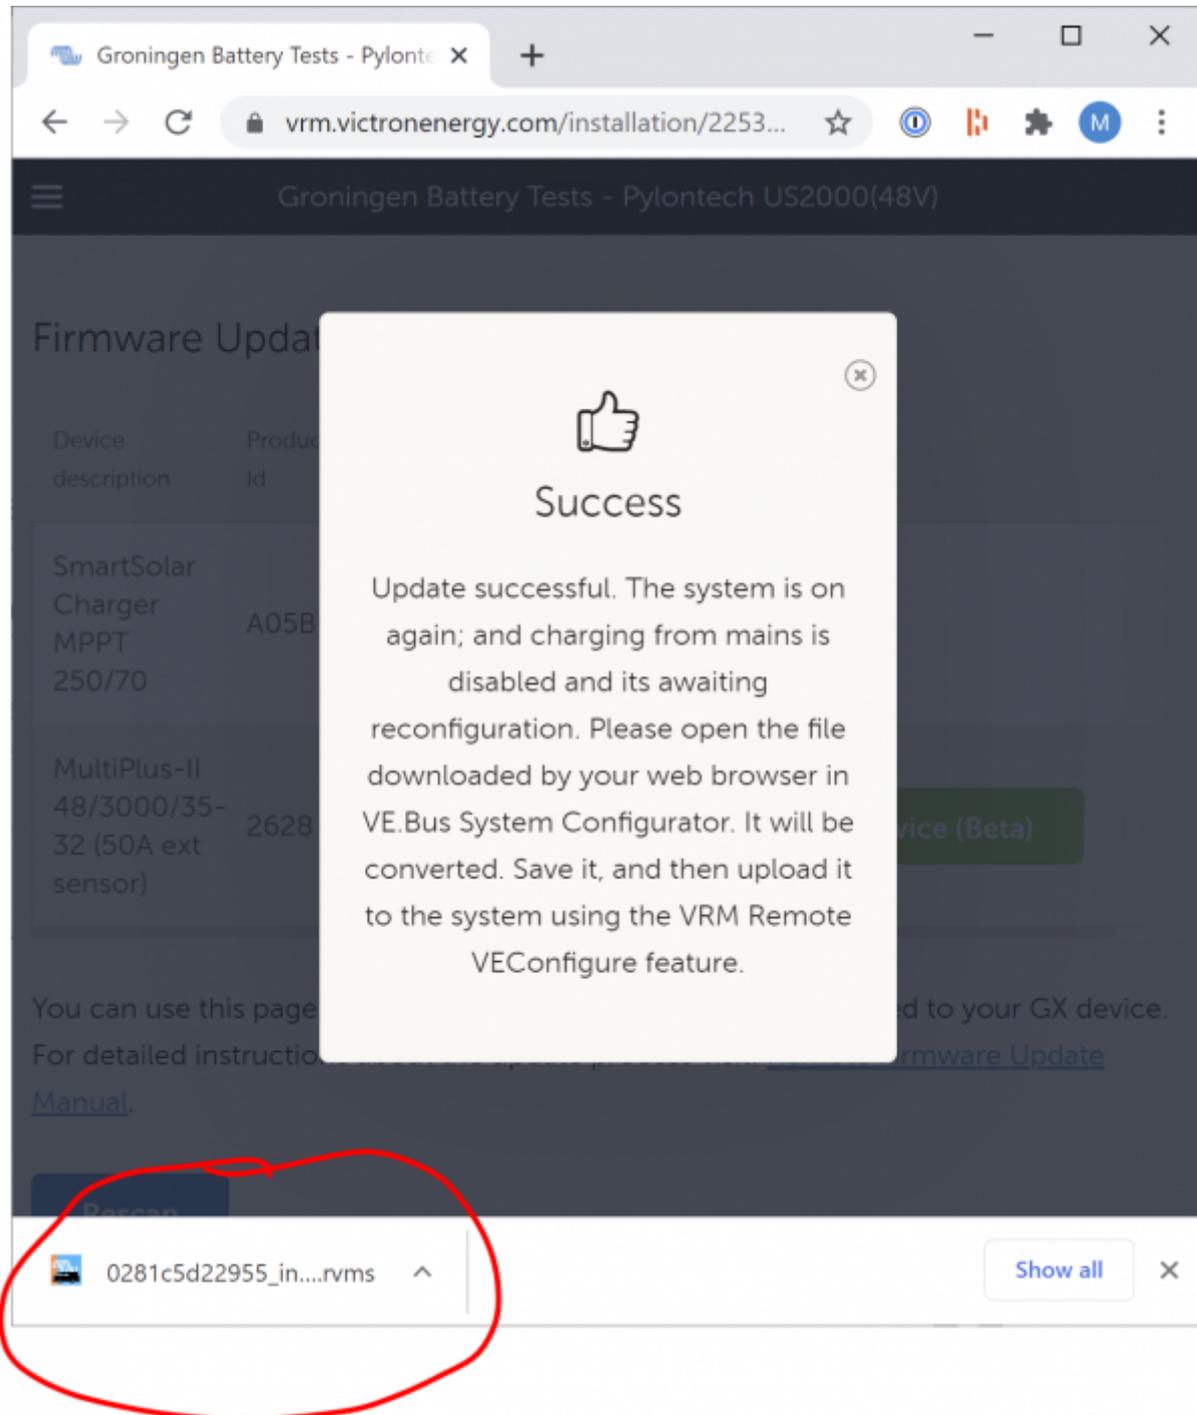
Now, the inverter is powered up, configured with default settings. In case the internet was lost, it will recover which might take a while to fully reconnect all systems. Once restored, the new settings template is retrieved from the system and will be available for download in your web browser.

At this point, the web browser shows below message. Note the downloaded settings template on the lower right:

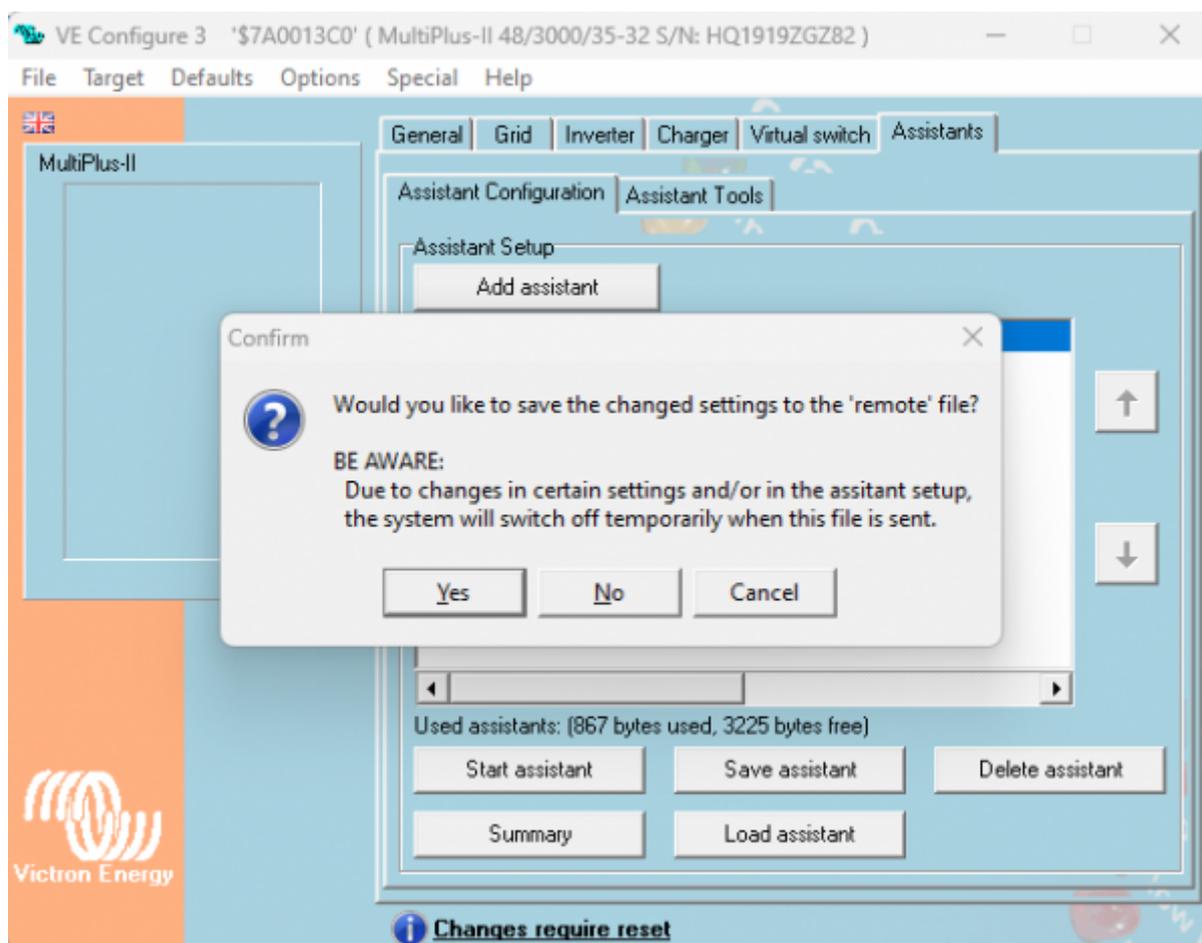
The settings template will need to be converted. It should be a .RVMS file in your download folder (it is saved during the update procedure). Open it by double clicking. If the VE.Bus tools are correctly installed, it will then open in VE.Bus System Configurator, and prompt you about the conversion.

Close VEConfigure (X on upper right of the window), which will automatically prompt saving that converted file:

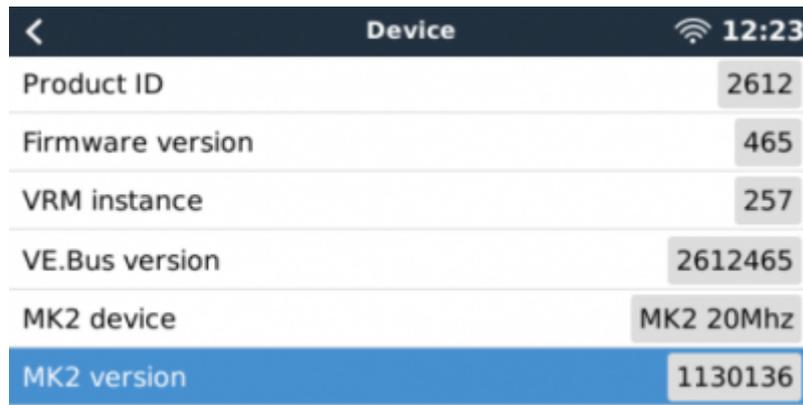
The other way is in the UI (either on the CCGX itself, or through Remote Console). Go to the Device List, then into the Multi or Quattro menu, then to the bottom, Device submenu, and scroll all the way to the bottom.

Here you'll see this menu:

The screenshot shows a mobile application interface with a dark header bar. The header contains a back arrow, the word "Device", a Wi-Fi icon, and the time "12:23". Below the header is a list of device information items, each with a label on the left and a value in a grey box on the right. The items are: Product ID (2612), Firmware version (465), VRM instance (257), VE.Bus version (2612465), MK2 device (MK2 20Mhz), and MK2 version (1130136). The "MK2 version" row is highlighted with a blue background.

Label	Value
Product ID	2612
Firmware version	465
VRM instance	257
VE.Bus version	2612465
MK2 device	MK2 20Mhz
MK2 version	1130136
