# Remote VE.Bus firmware updates

This feature allows remotely updating the firmware of Victron inverter as well as inverter/charger. Applicable to systems that have a [GX device](#) installed, and being internet-connected to the [VRM Portal](#).

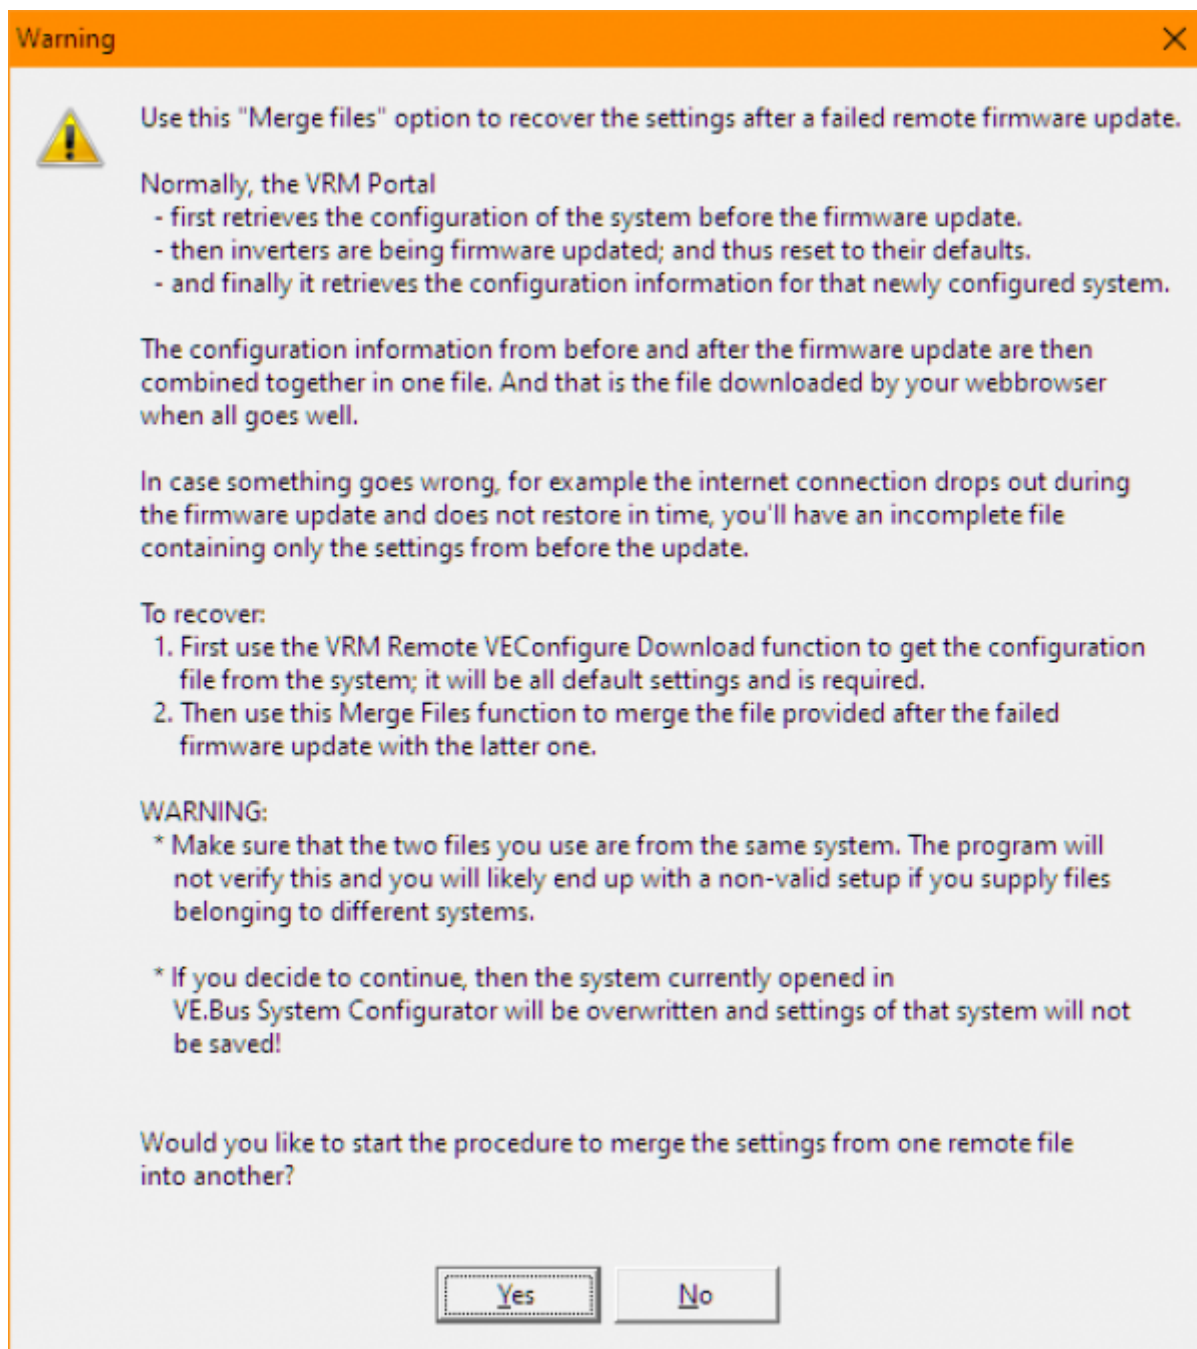
1. In VRM → Device List → Remote VEConfigure, and there click download.
2. Use the merge function in VE.Bus System Configurator:

Use this "Merge files" option to recover the settings after a failed remote firmware update.

1. First use the VRM Remote VEConfigure Download function to get the configuration file from the system; it will be all default settings and is required.
2. Then use this Merge Files function to merge the file provided after the failed firmware update with the latter one.
