# Remote VE.Bus firmware updates

### 1.1 Introduction

This feature allows remotely updating the firmware of Victron inverter as well as inverter/charger. Applicable to systems that have a [GX device](#) installed, and being internet-connected to the [VRM Portal](#).

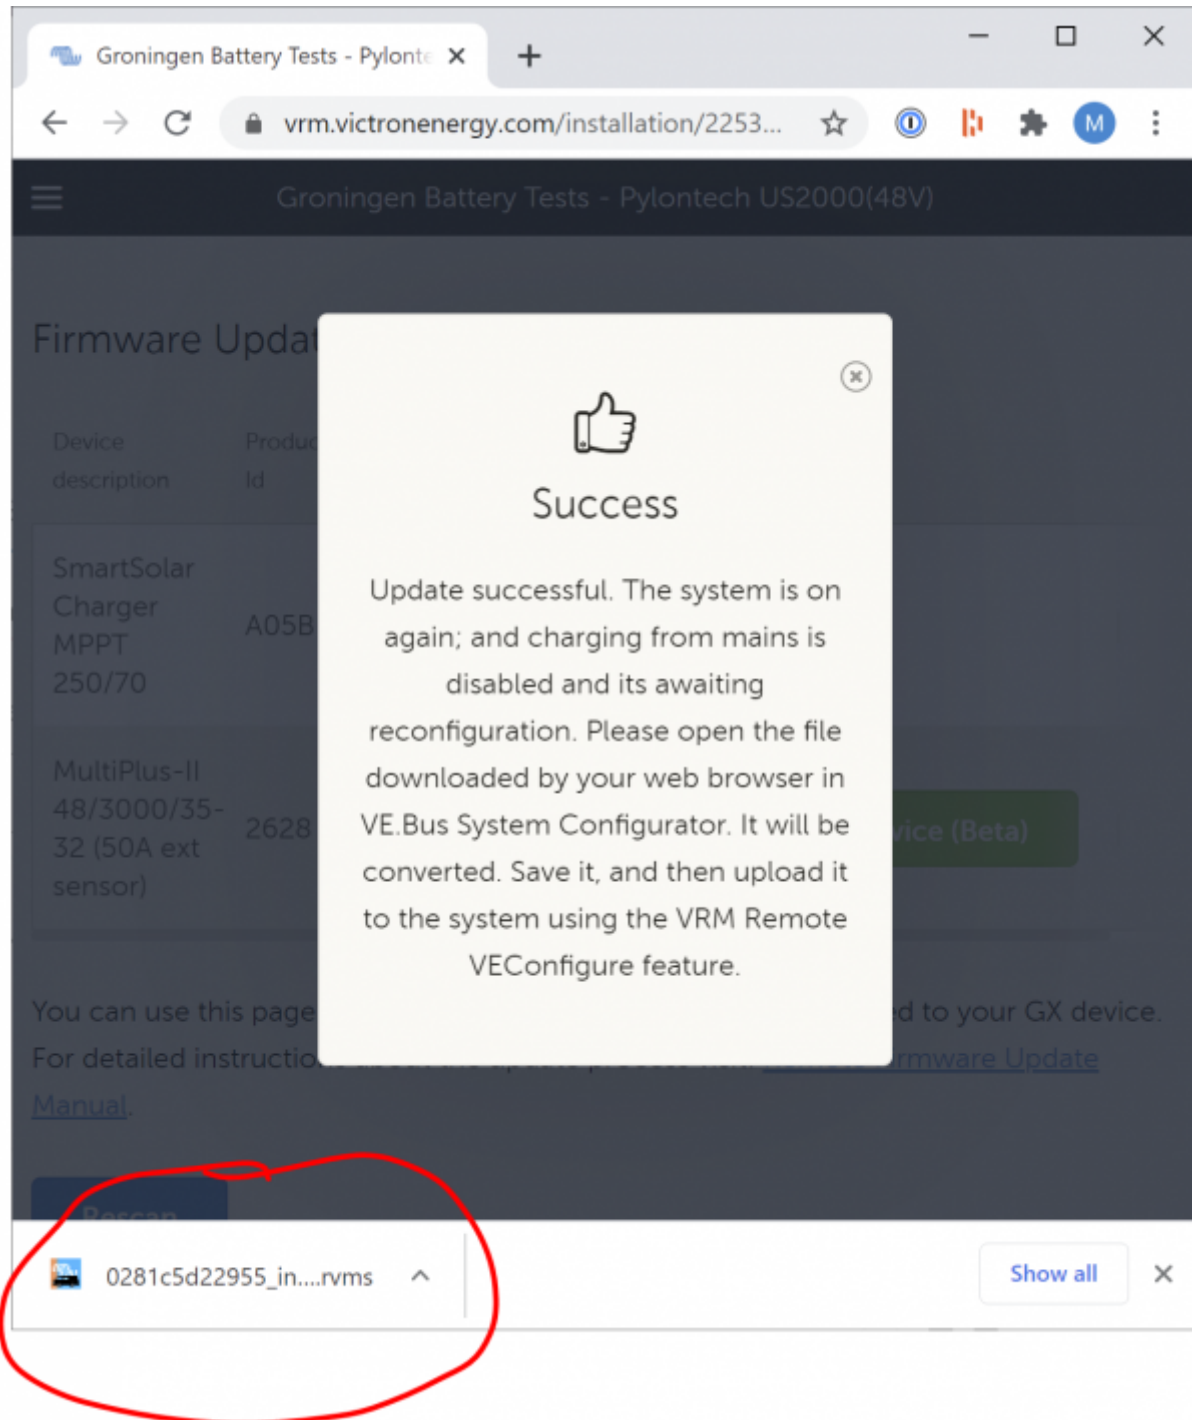
Now, the inverter is powered up, configured with default settings. In case the internet was lost, it will recover which might take a while to fully reconnect all systems. Once restored, the new settings template is retrieved from the system and will be available for download in your web browser.

At this point, the web browser shows below message. Note the downloaded settings template on the lower right:

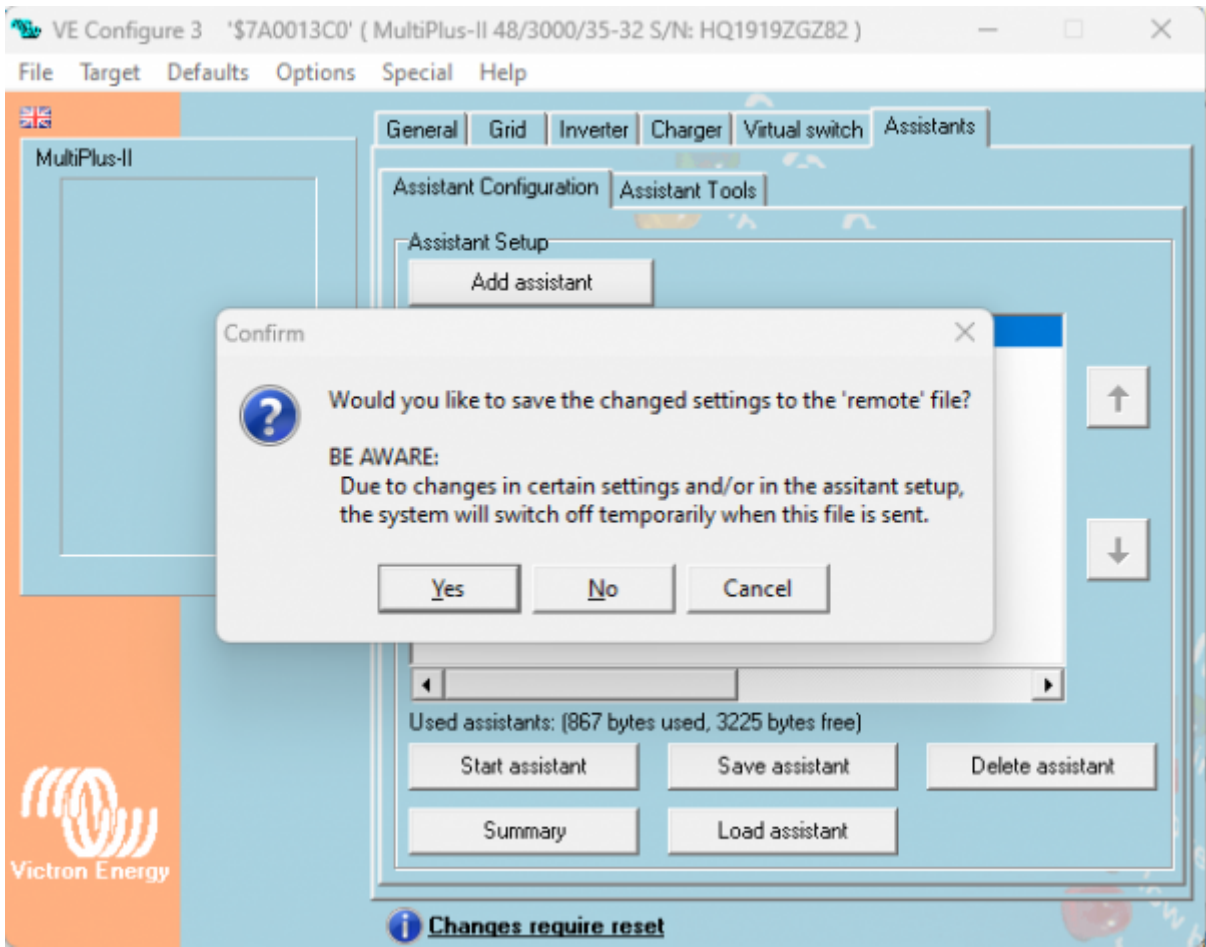
The settings template will need to be converted. It should be a .RVMS file in your download folder (it is saved during the update procedure). Open it by double clicking. If the VE.Bus tools are correctly installed, it will then open in VE.Bus System Configurator, and prompt you about the conversion.

Close VEConfigure (X on upper right of the window), which will automatically prompt saving that converted file:

Now upload the converted file. On the VRM Portal, go to the Device List → Remote VEConfigure menu → 'Upload' the converted file.
