Remote VE.Bus firmware updates

1. Introduction and limitations

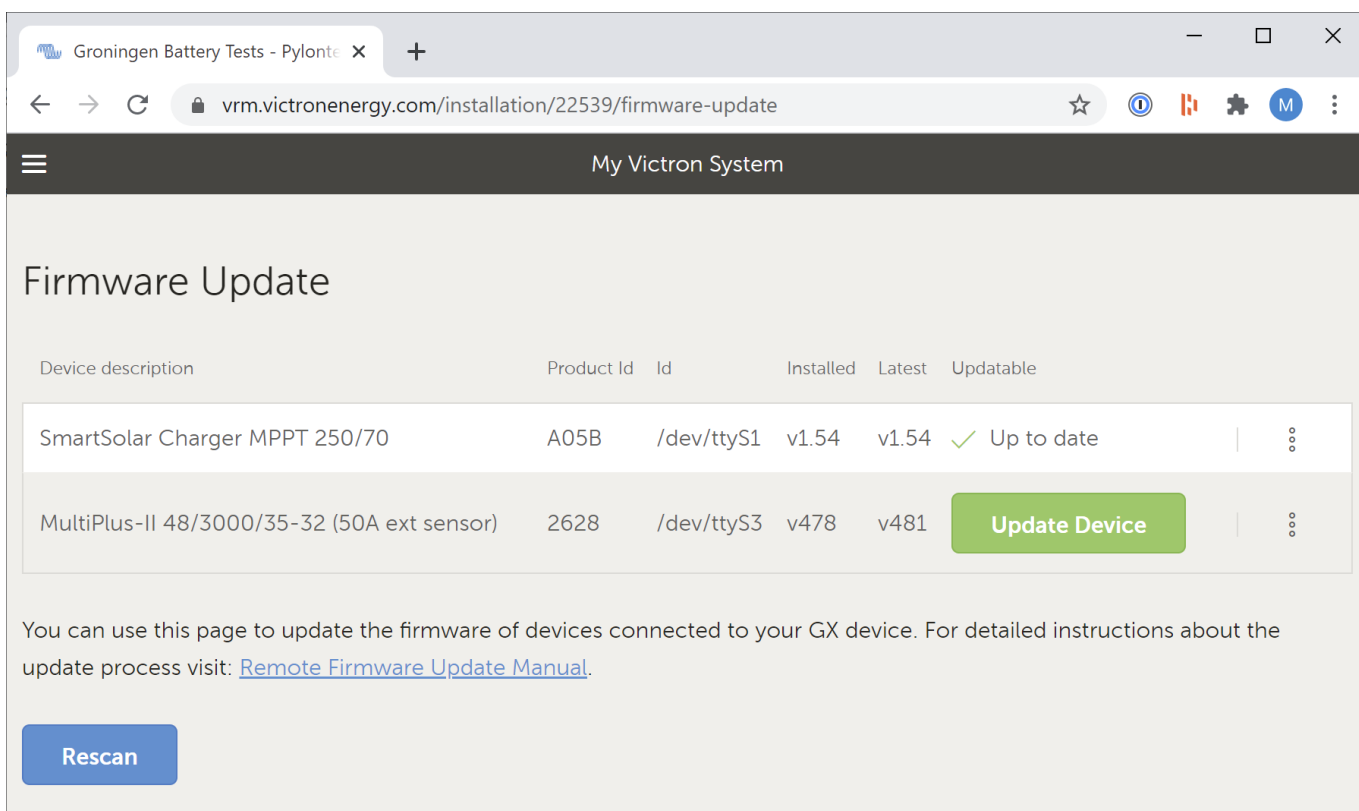
In the VRM Portal, go to the Device List page, and click the Firmware update button at the bottom of the page. The system will now search for connected devices and once completed show the result:

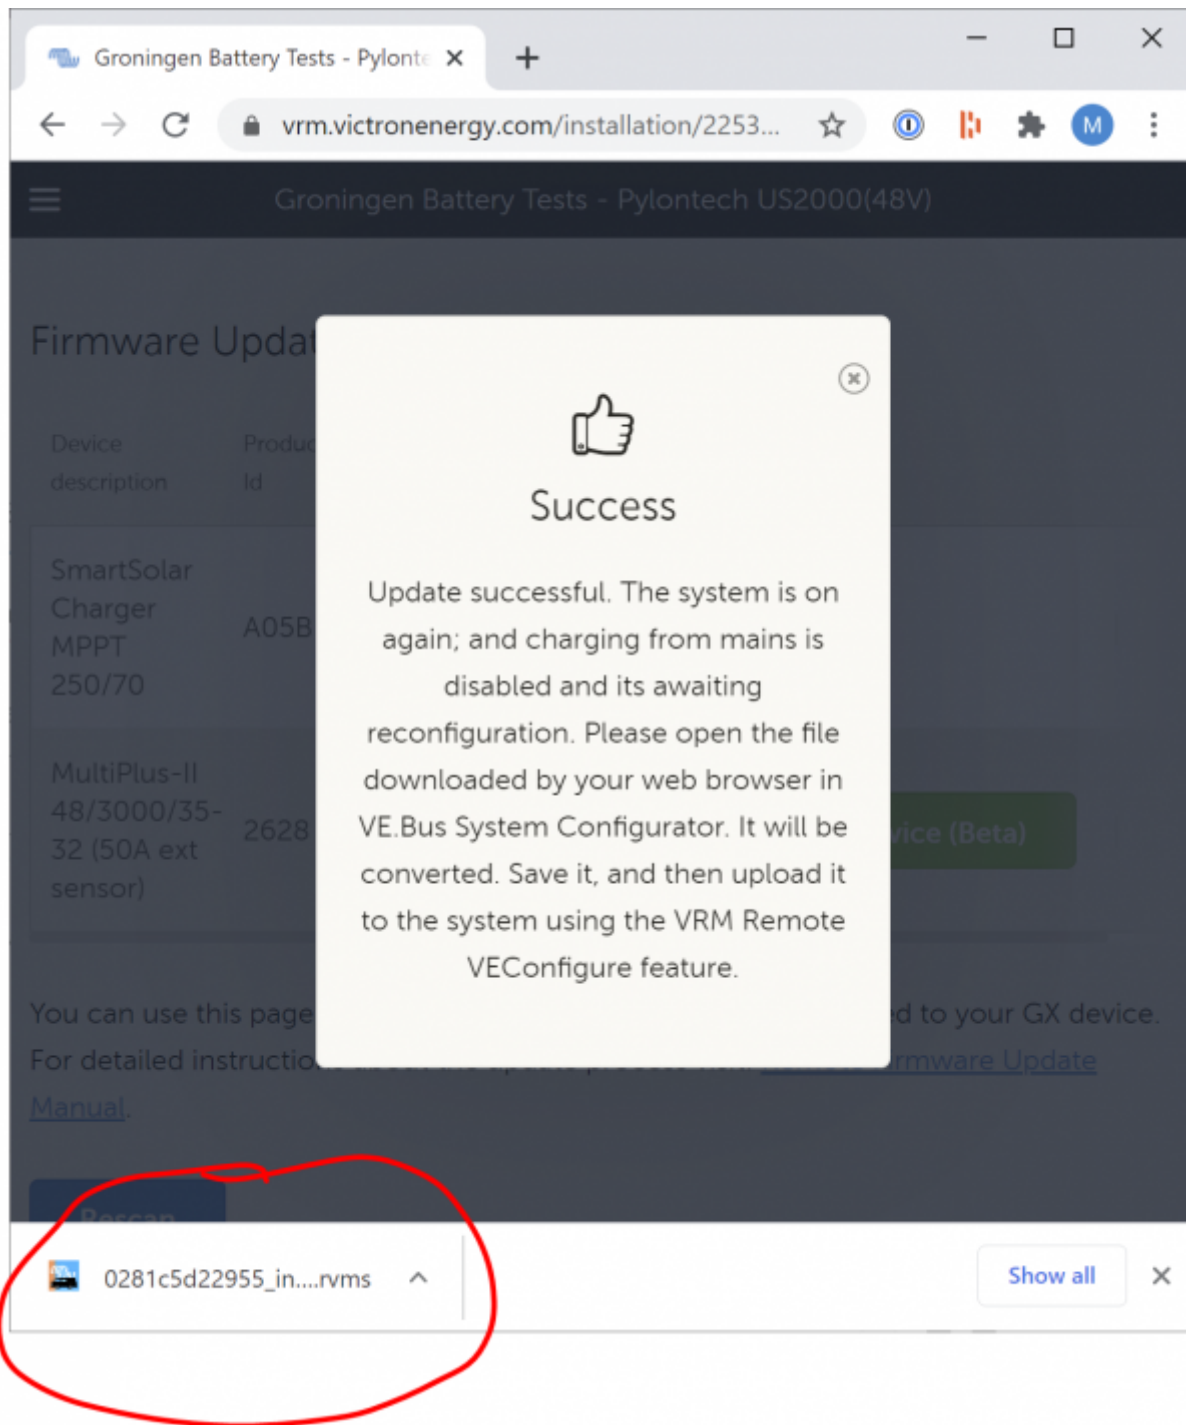
At this point, the web browser shows below message. Note the downloaded settings template on the lower right:

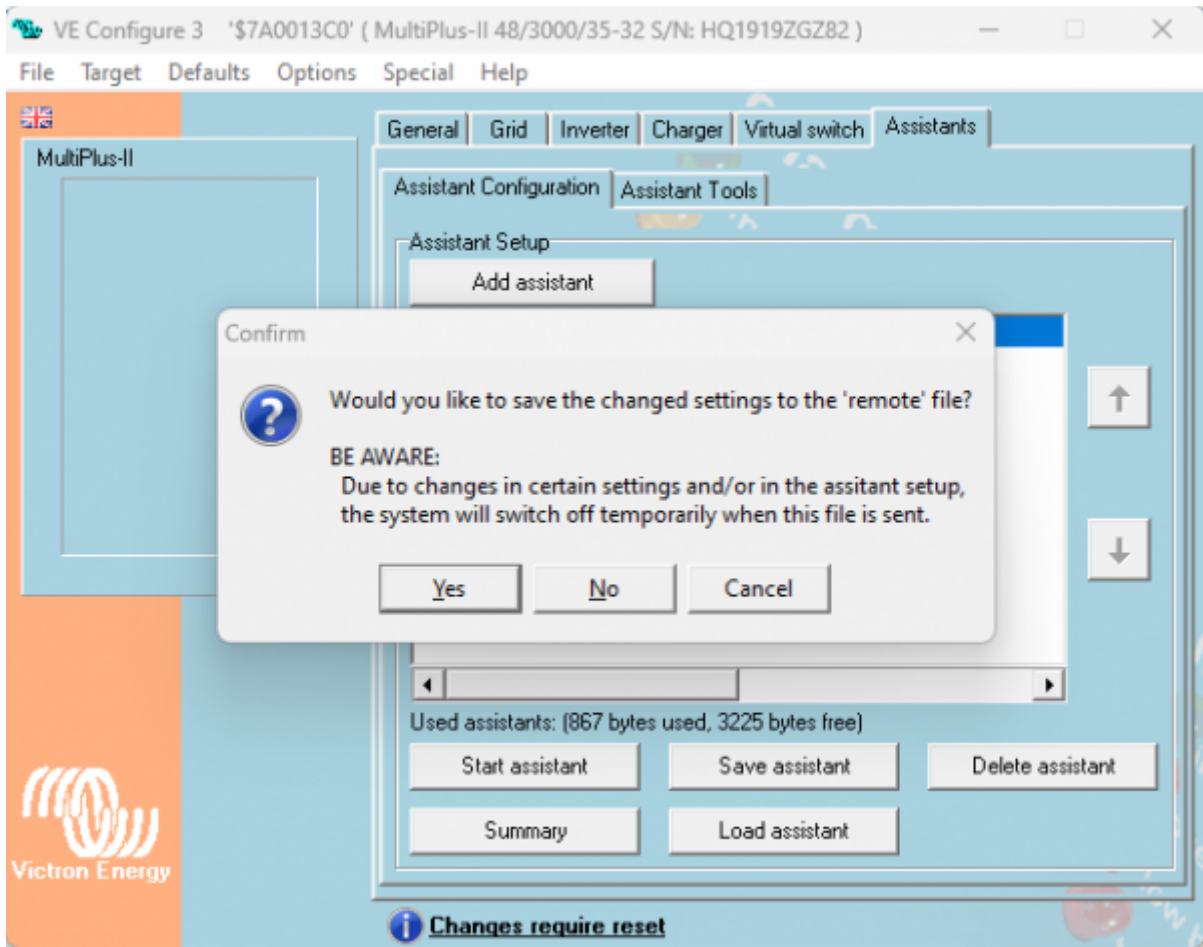
The settings template will need to be converted. It should be a .RVMS file in your download folder (it is saved during the update procedure). Open it by double clicking. If the VE.Bus tools are correctly installed, it will then open in VE.Bus System Configurator, and prompt you about the conversion.

Close VEConfigure (X on upper right of the window), which will automatically prompt saving that converted file:
