Remote VE.Bus firmware updates

1. Introduction and limitations

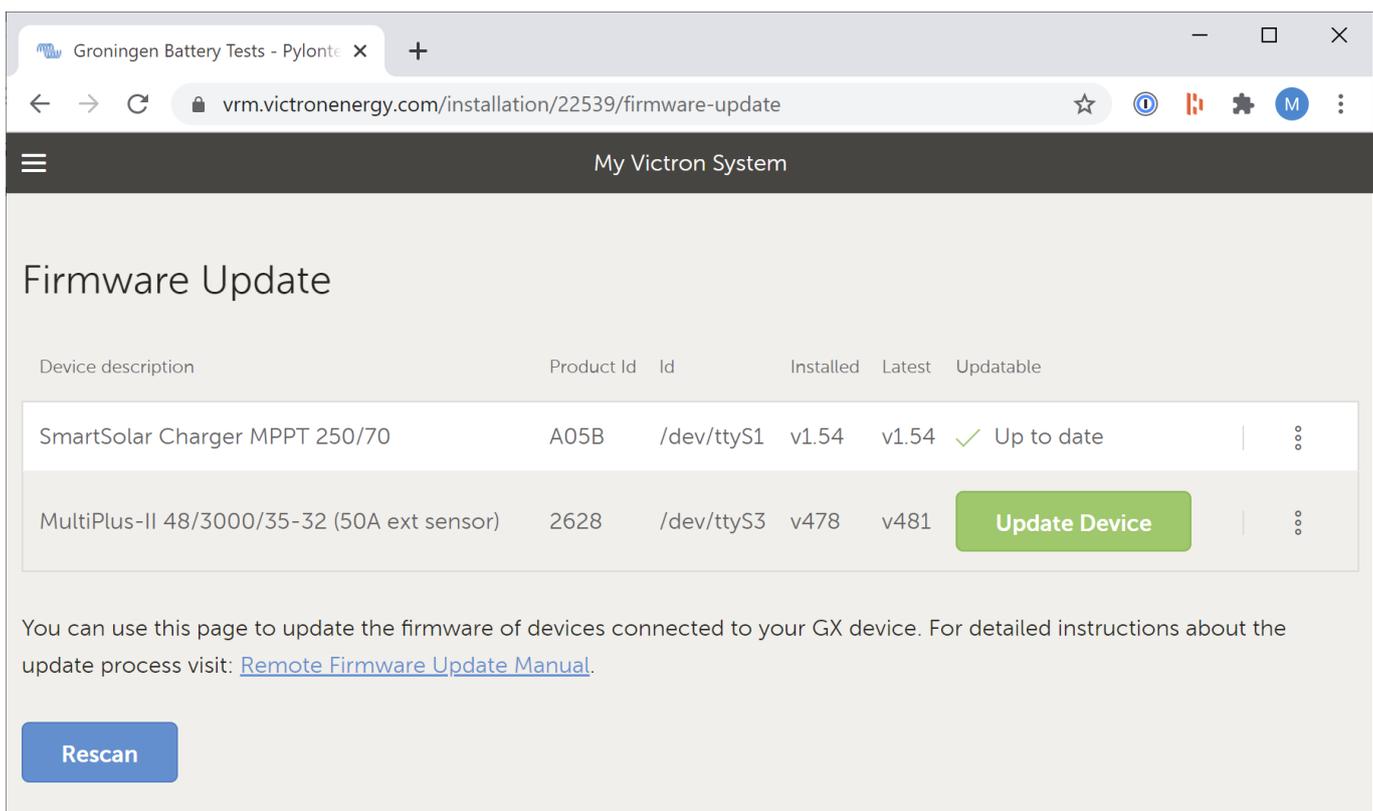
In the VRM Portal, go to the Device List page, and click the Firmware update button at the bottom of the page. The system will now search for connected devices and once completed show the result:

The already installed firmware version can be see here, the encircled number must be above 426.

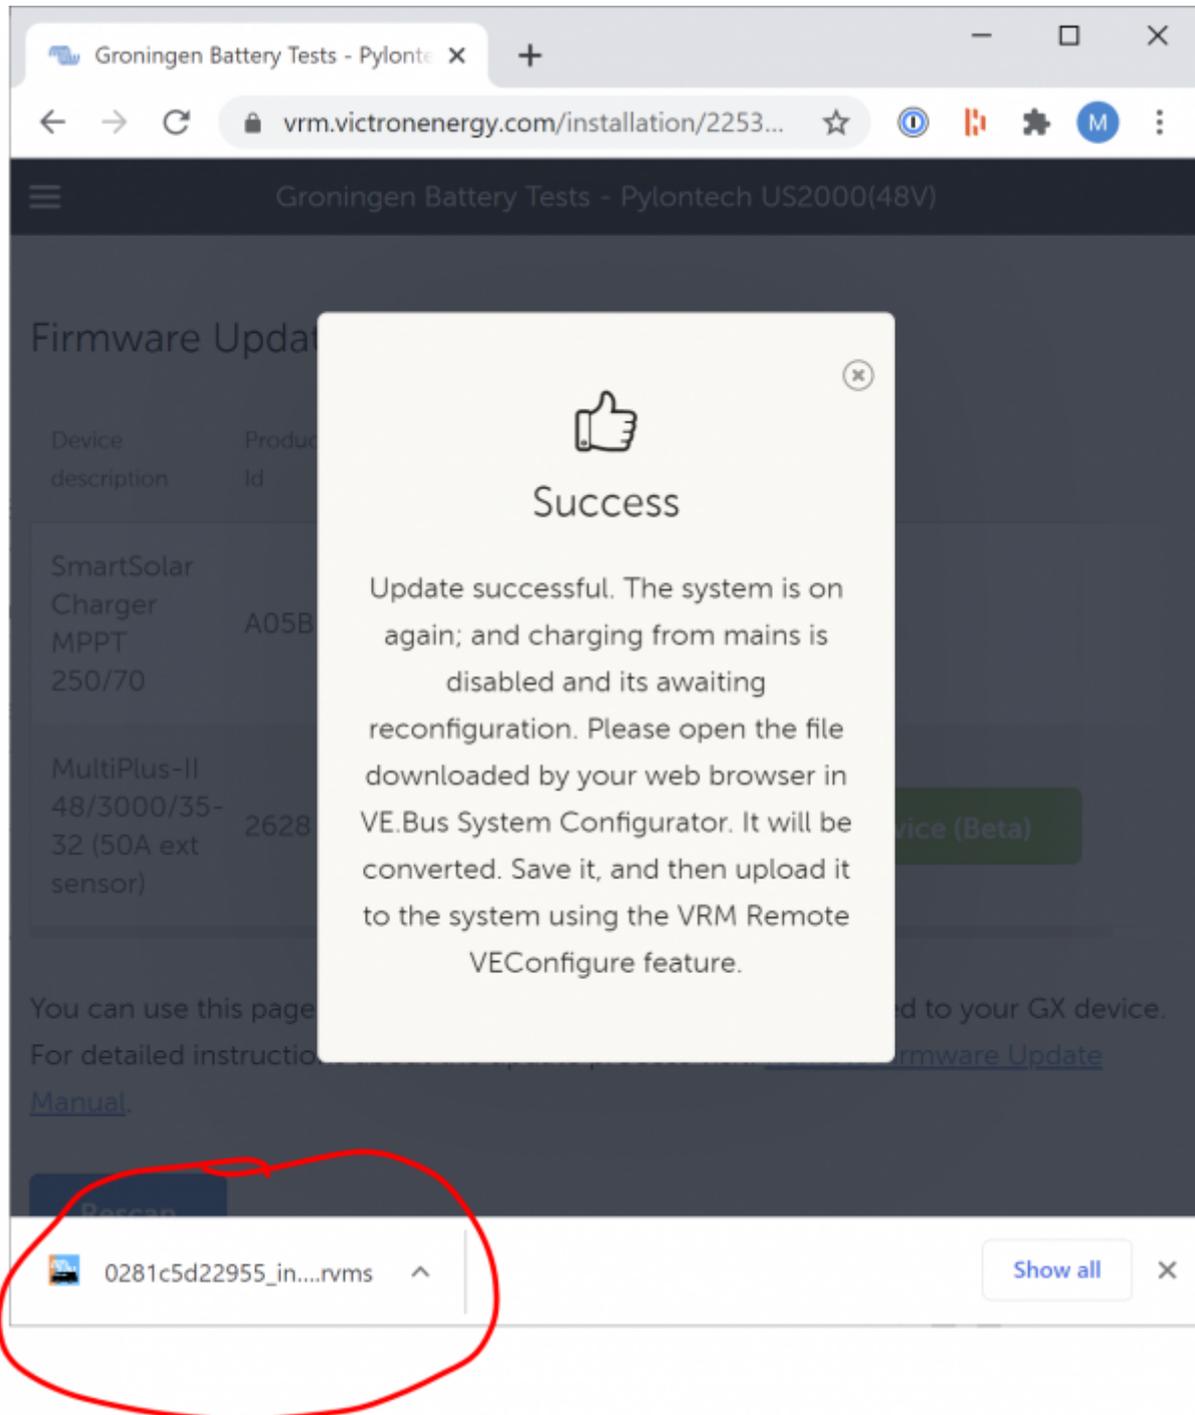
Now, the inverter is powered up, configured with default settings. In case the internet was lost, it will recover which might take a while to fully reconnect all systems. Once restored, the new settings template is retrieved from the system and will be available for download in your web browser.

At this point, the web browser shows below message. Note the downloaded settings template on the lower right:

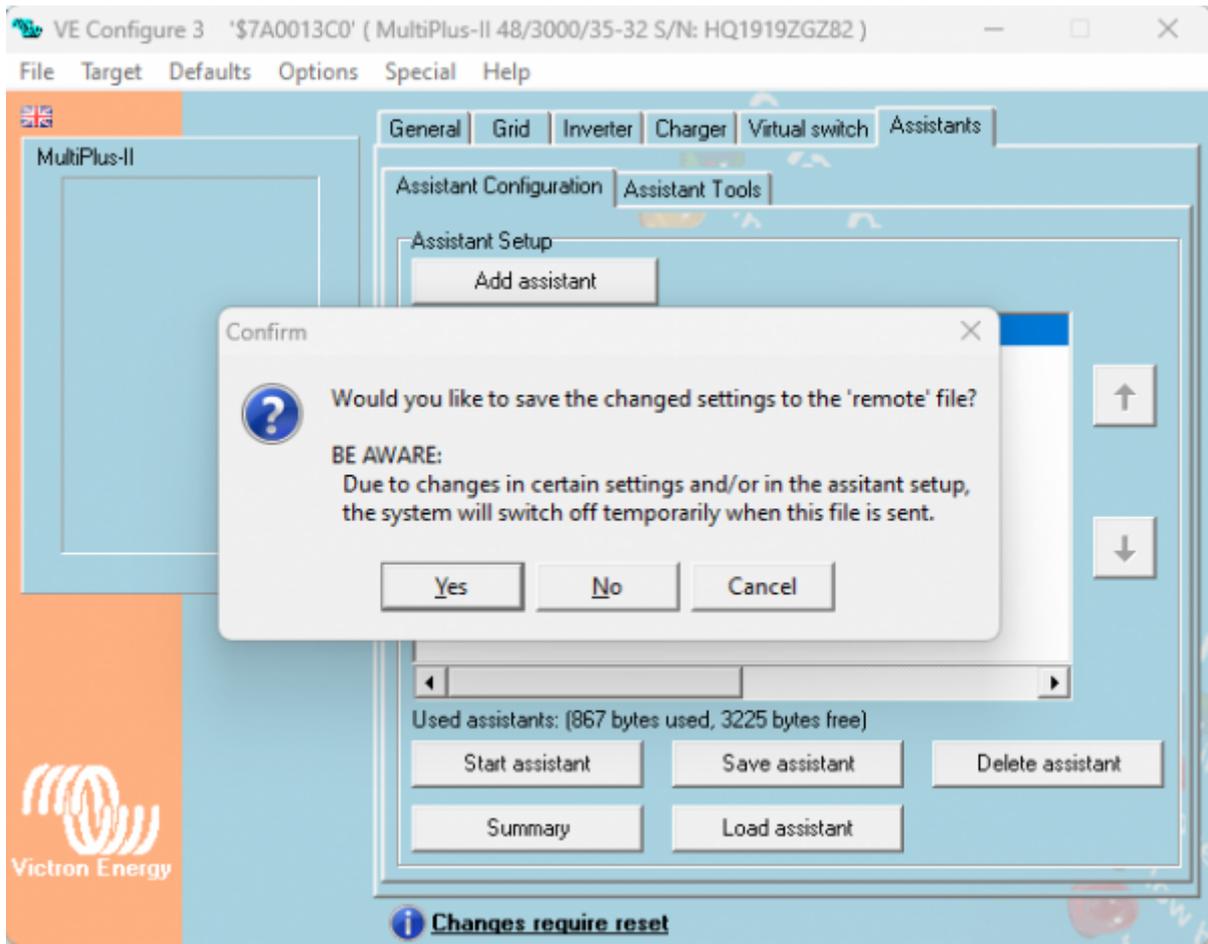
The settings template will need to be converted. It should be a .RVMS file in your download folder (it is saved during the update procedure). Open it by double clicking. If the VE.Bus tools are correctly installed, it will then open in VE.Bus System Configurator, and prompt you about the conversion.

Close VEConfigure (X on upper right of the window), which will automatically prompt saving that converted file:

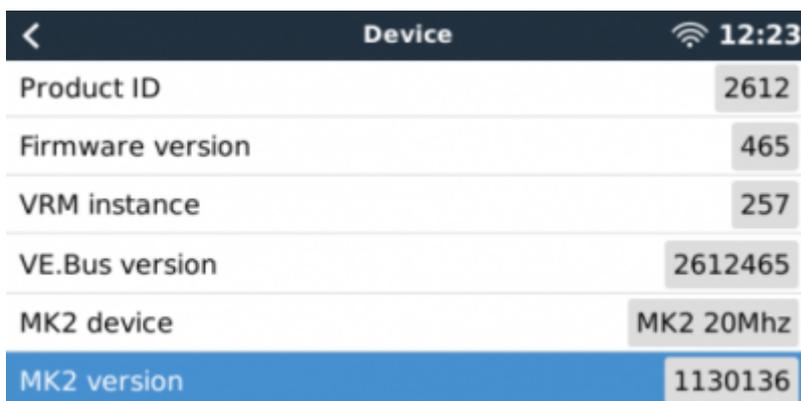
The other way is in the UI (either on the CCGX itself, or through Remote Console). Go to the Device List, then into the Multi or Quattro menu, then to the bottom, Device submenu, and scroll all the way to the bottom.

Here you'll see this menu:

Device	
Product ID	2612
Firmware version	465
VRM instance	257
VE.Bus version	2612465
MK2 device	MK2 20Mhz
MK2 version	1130136

It needs to say MK3. Above screenshot is from a CCGX which hardware is too old to perform remote VE.Bus firmware updates.

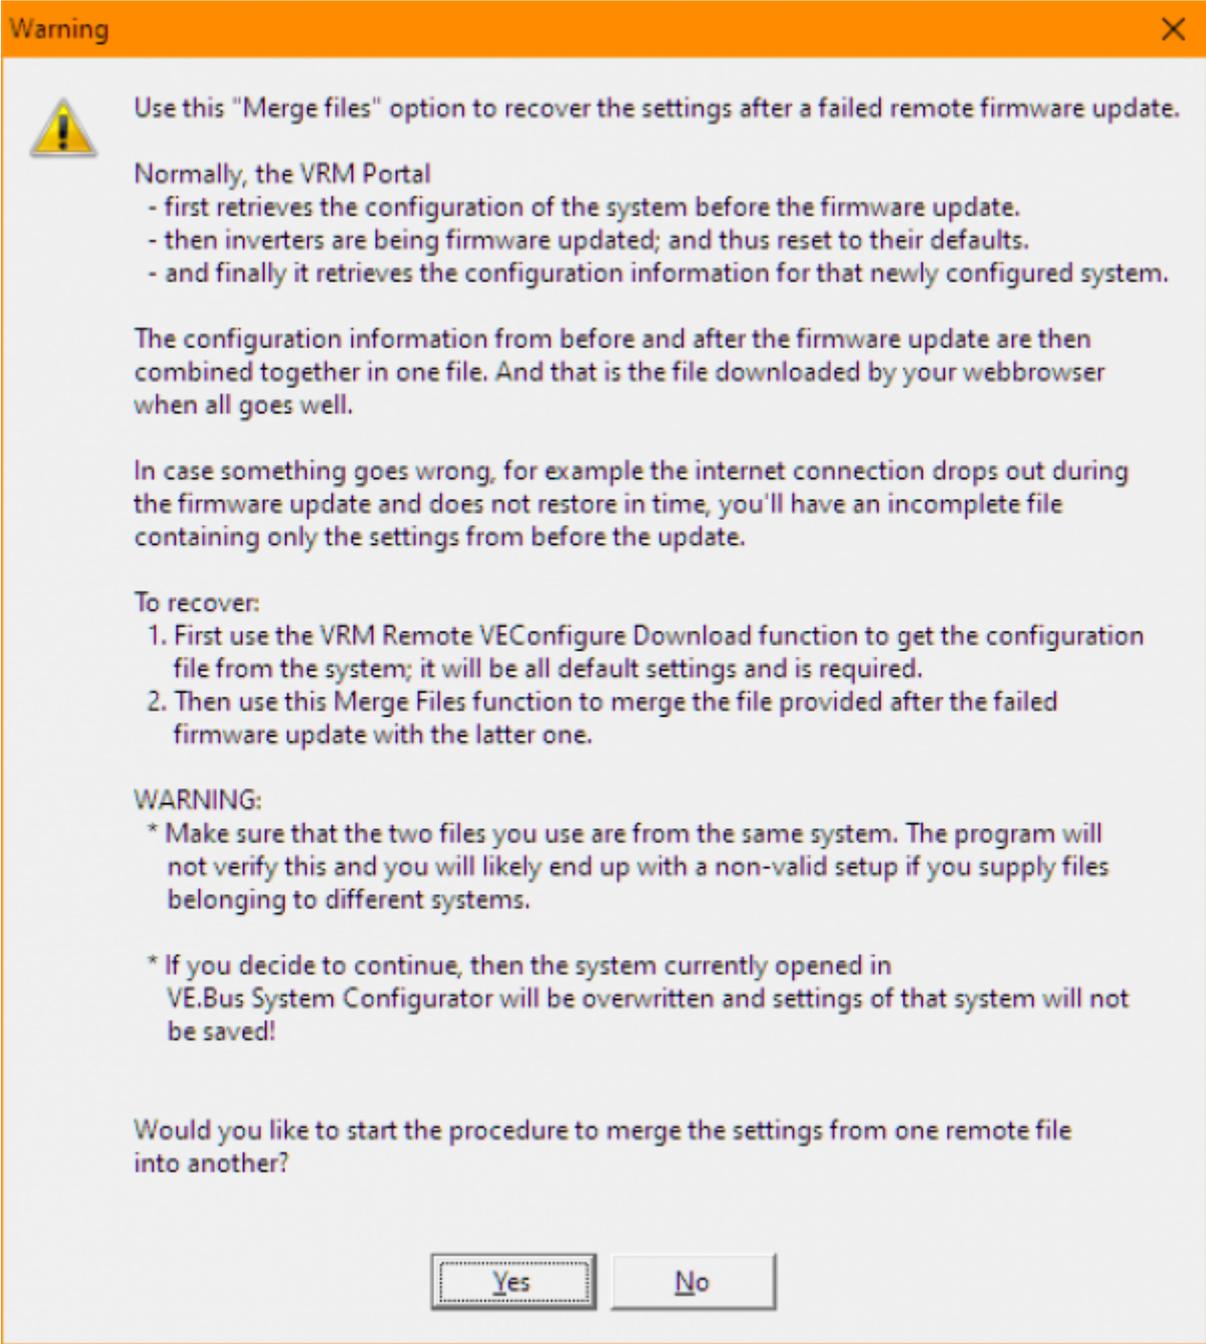
1. In VRM → Device List → Remote VEConfigure, and there click download.
2. Use the merge function in VE.Bus System Configurator:

Use this "Merge files" option to recover the settings after a failed remote firmware update.

1. First use the VRM Remote VEConfigure Download function to get the configuration file from the system; it will be all default settings and is required.
2. Then use this Merge Files function to merge the file provided after the failed firmware update with the latter one.
