Remote VE.Bus firmware updates

1. Introduction and limitations

1.1 Introduction

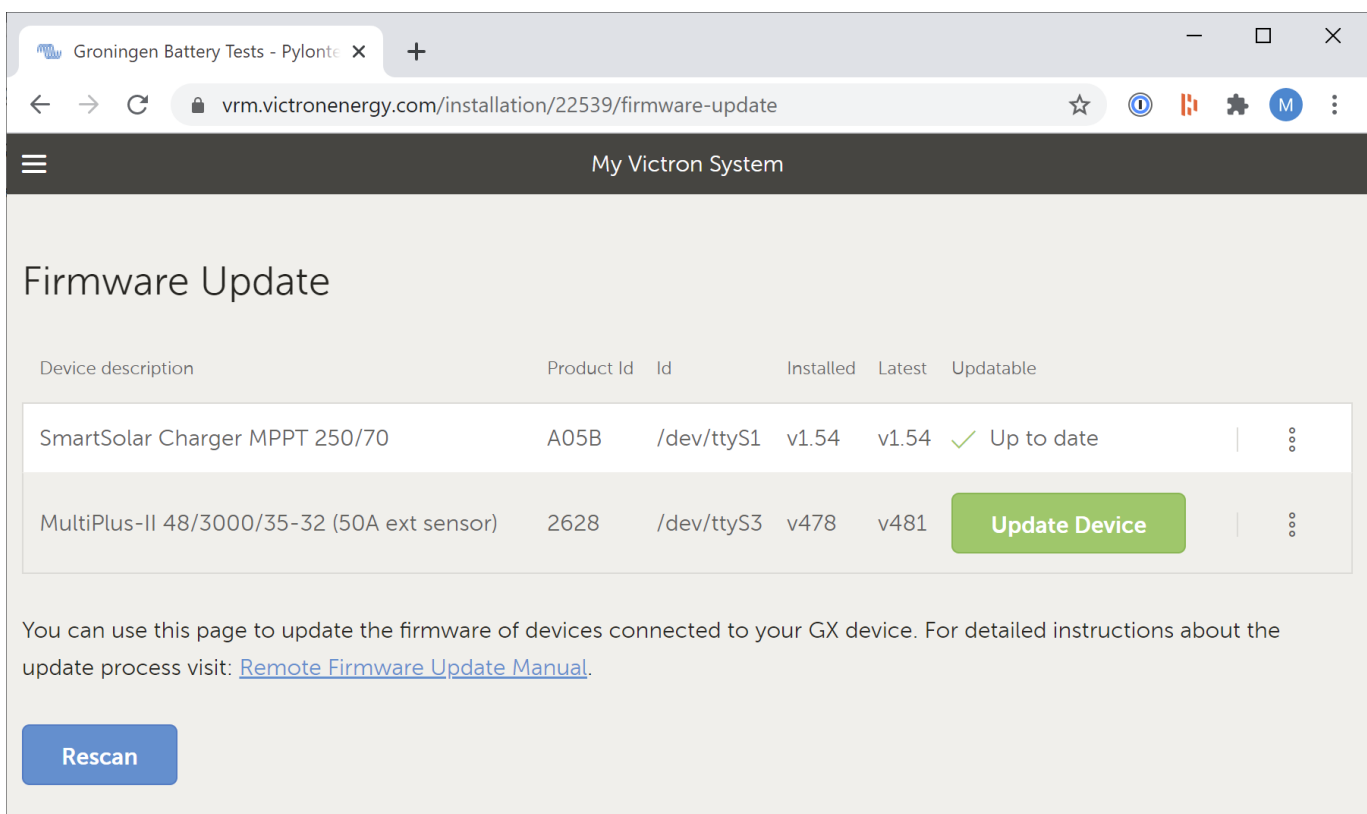
In the VRM Portal, go to the Device List page, and click the Firmware update button at the bottom of the page. The system will now search for connected devices and once completed show the result:

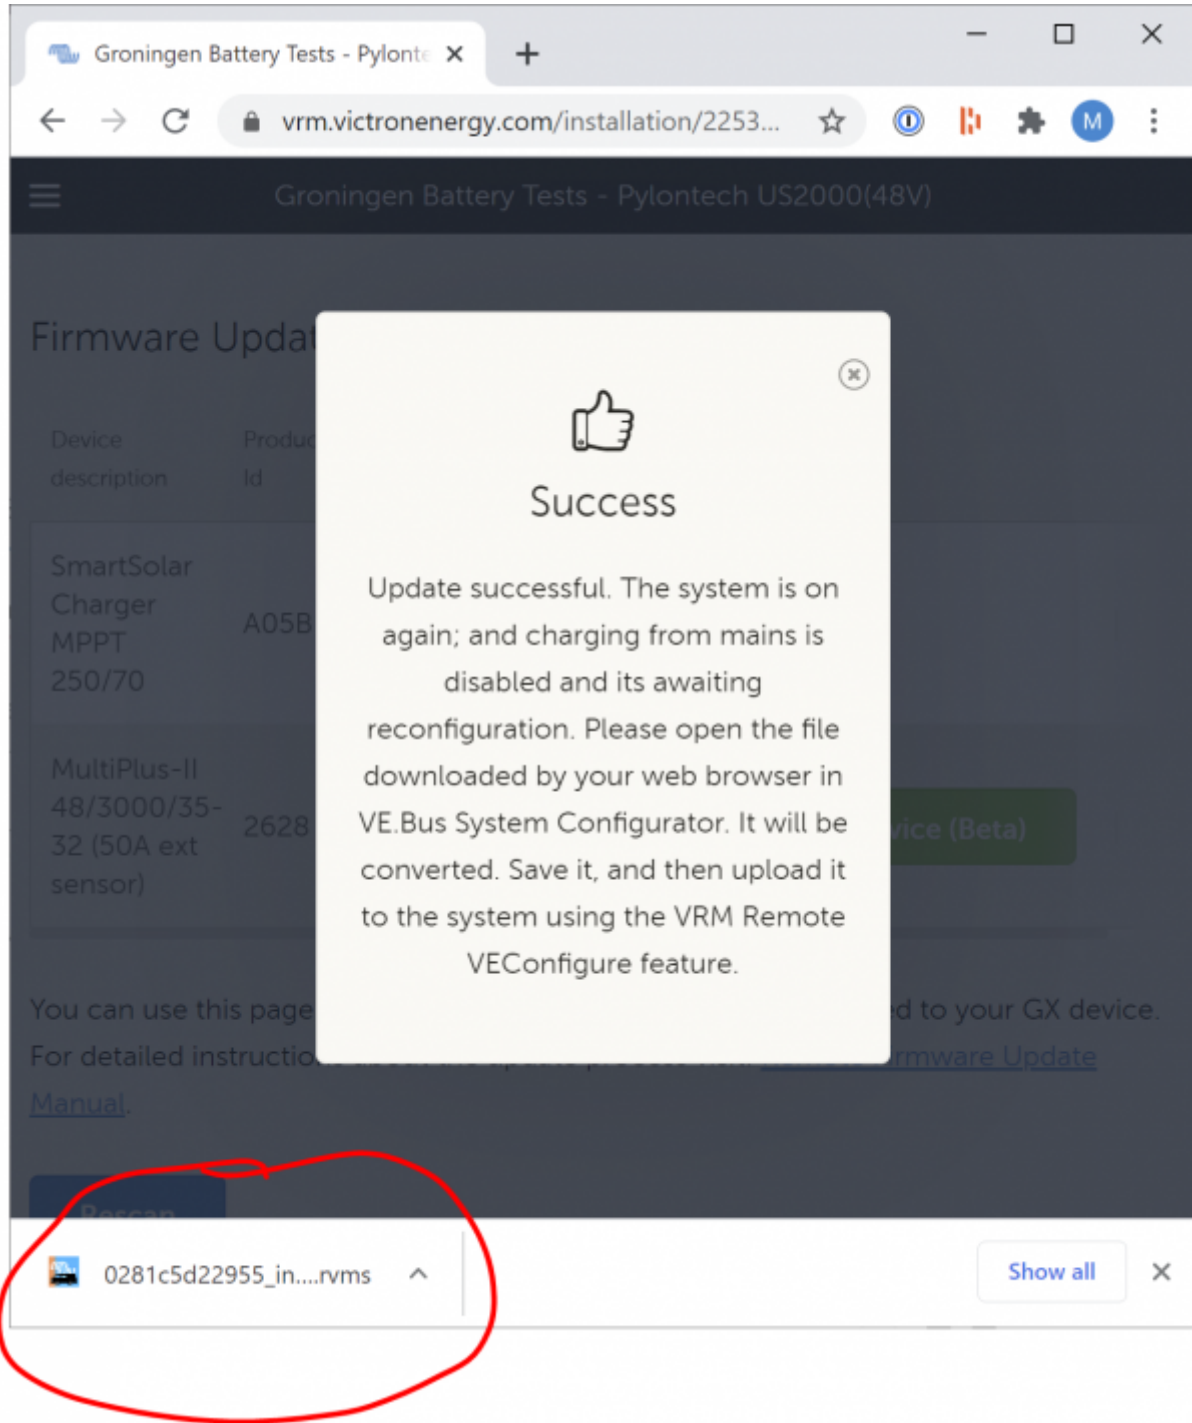
Now, the inverter is powered up, configured with default settings. In case the internet was lost, it will recover which might take a while to fully reconnect all systems. Once restored, the new settings template is retrieved from the system and will be available for download in your web browser.

At this point, the web browser shows below message. Note the downloaded settings template on the lower right:

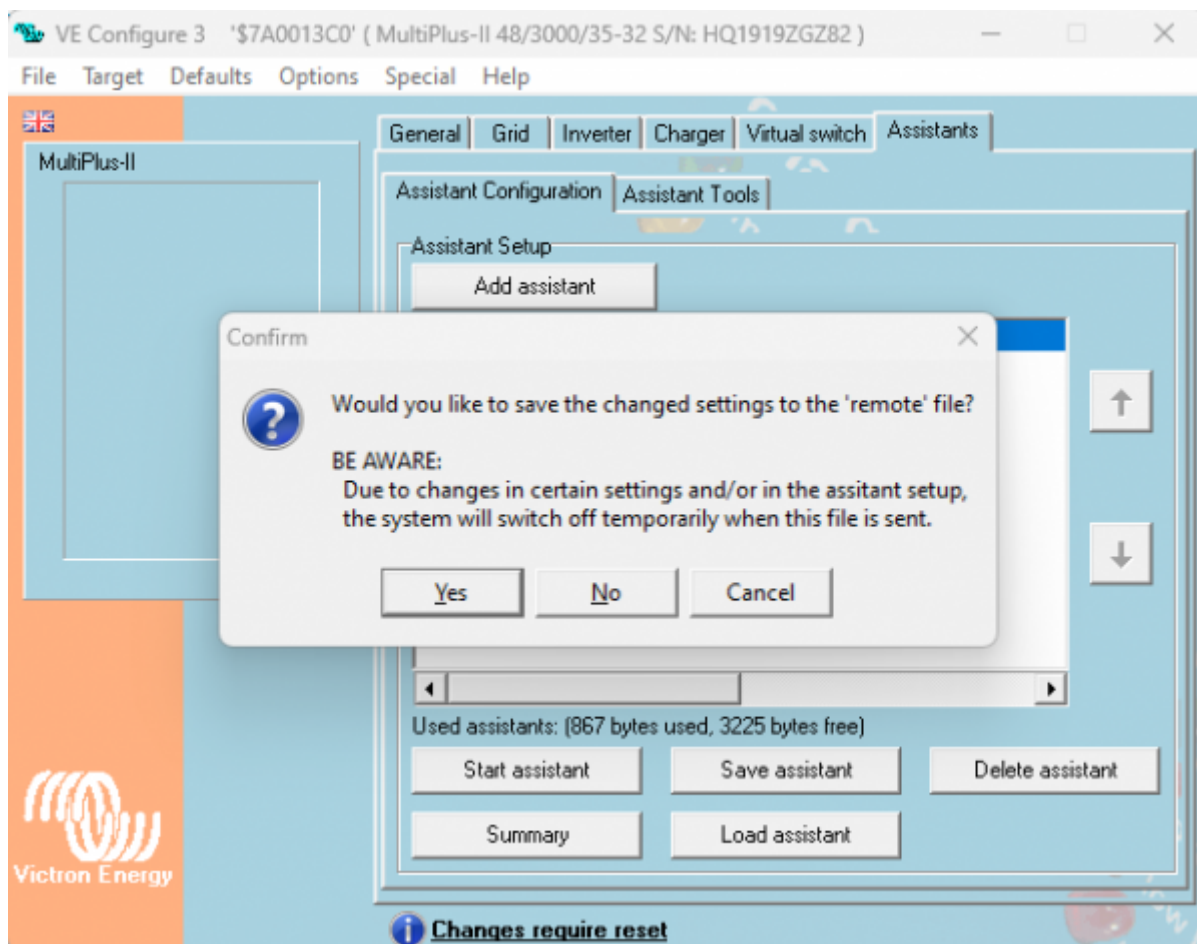
The settings template will need to be converted. It should be a .RVMS file in your download folder (it is saved during the update procedure). Open it by double clicking. If the VE.Bus tools are correctly installed, it will then open in VE.Bus System Configurator, and prompt you about the conversion.

Close VEConfigure (X on upper right of the window), which will automatically prompt saving that converted file:
