Troubleshooting CCGX to VRM connectivity

This document outlines the procedure to troubleshoot connectivity between a CCGX and the VRM Portal.

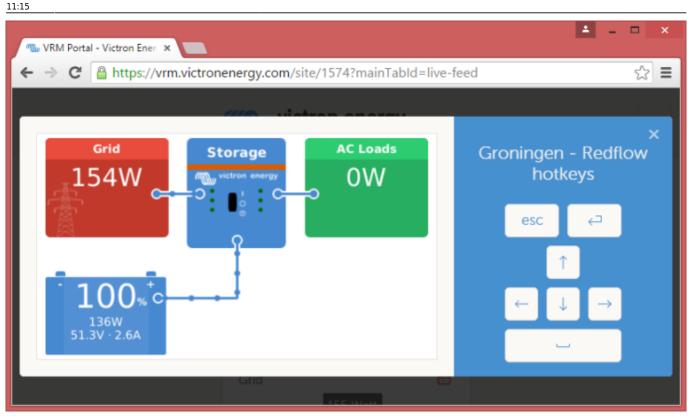
The Remote Console on VRM feature allows full remote control of a CCGX, over the internet:

After enabling the feature in the CCGX setting menu, setting or disabling the password, and then restarting the CCGX, a green button will show on the VRM website. Click it to open the Remote Console.

- 1. First make sure that basic communication with VRM works, see above steps.
- 2. After enabling the feature, make sure to set (or disable) the password.
- 3. Then restart the CCGX.
- 4. Make sure to update the CCGX to the latest firmware version: v2.11 or newer.
- 5. After the restart, check the Remote Console on VRM status shows online or a port number. In case it says offline, or port number 0, the CCGX was unable to connect to the Remote Console server. This is normally caused by a (company) firewall, blocking the connection. The solution is then to configure an exception rules in the firewall.
- 6. Verify that your local web browser can access the websocket port (8080 on
